BUILDING PERFORMANCE: HURRICANE ANDREW IN FLORIDA

OBSERVATIONS, RECOMMENDATIONS,
AND TECHNICAL GUIDANCE

FEDERAL EMERGENCY MANAGEMENT AGENCY
FEDERAL INSURANCE ADMINISTRATION

DECEMBER 21, 1992

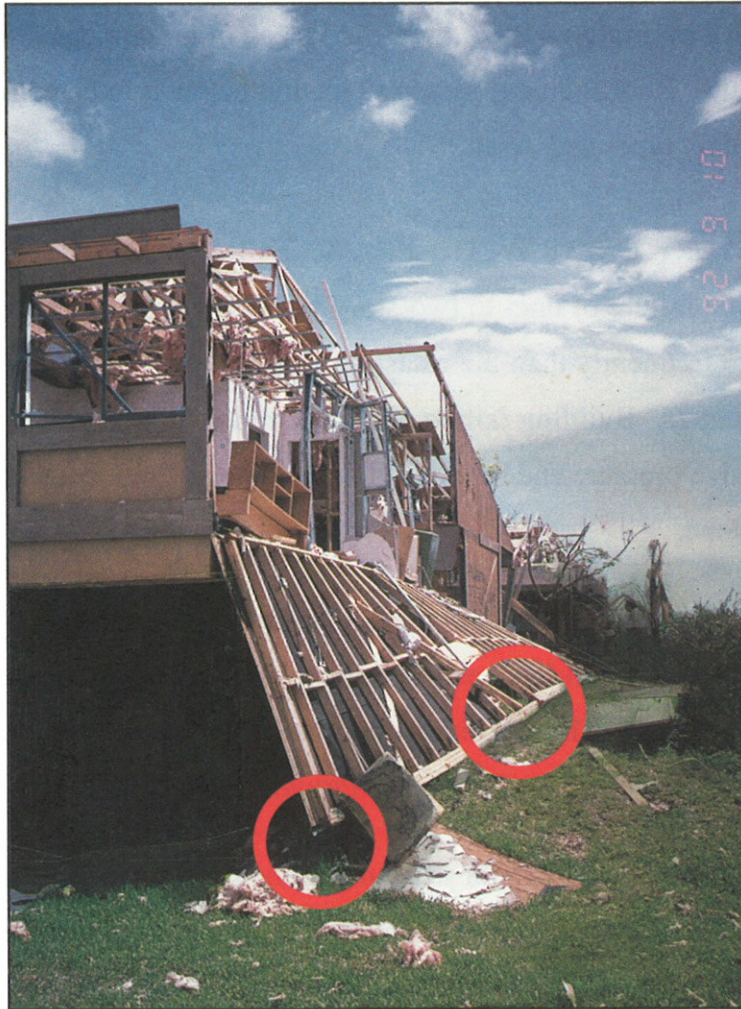
An absence of or improper installation of framing connections, load transfer straps, or bracing from non-loadbearing walls to connecting wall and roof components was noted. This condition contributed significantly to the primary failure of the framing system (SEE FIGURES 4 AND 5).

FIGURE 4.
Exterior wood-frame non-loadbearing wall. Transfer of wind forces from wall to adjoining structure was not sufficient.

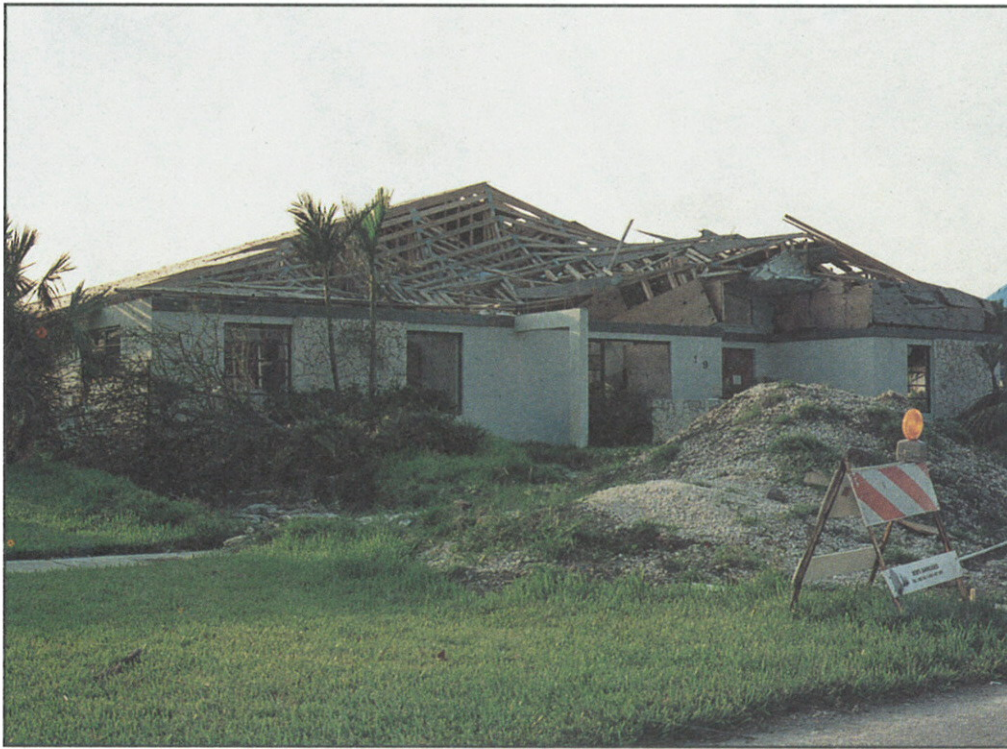
FIGURE 7. *Typical gable failure. Inadequate bracing support and ridge blocking evident in inward collapse.*

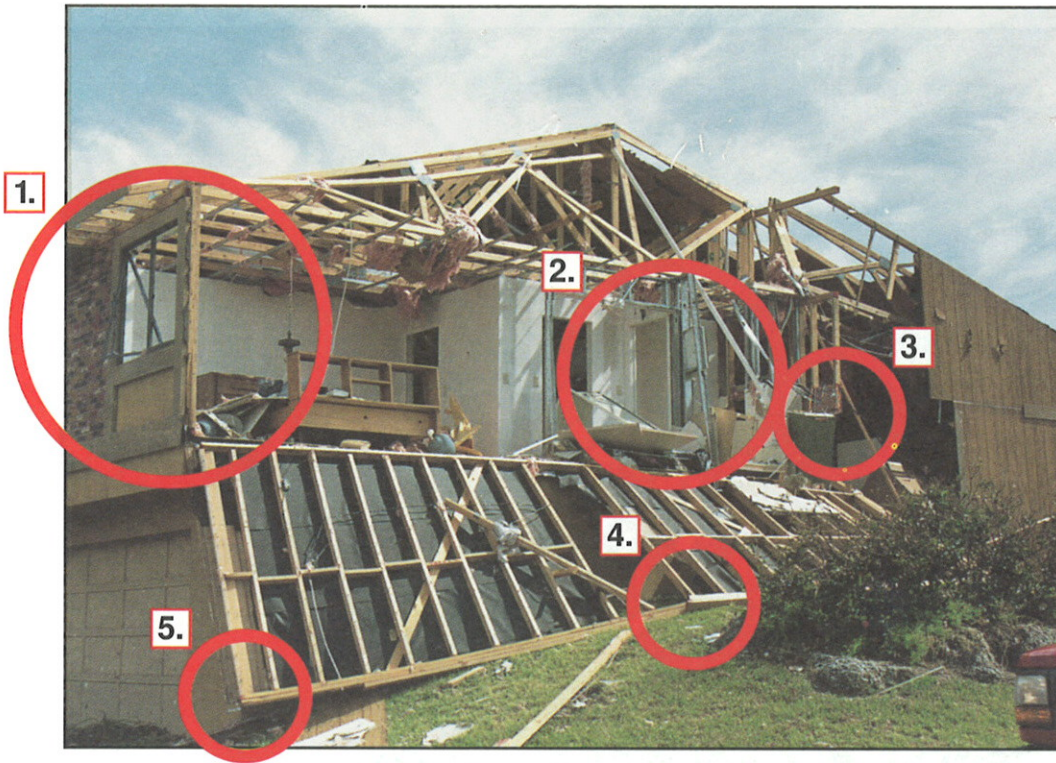
FIGURE 9. *Failure of non-loadbearing wall. Connections of exterior wall were not adequate.*

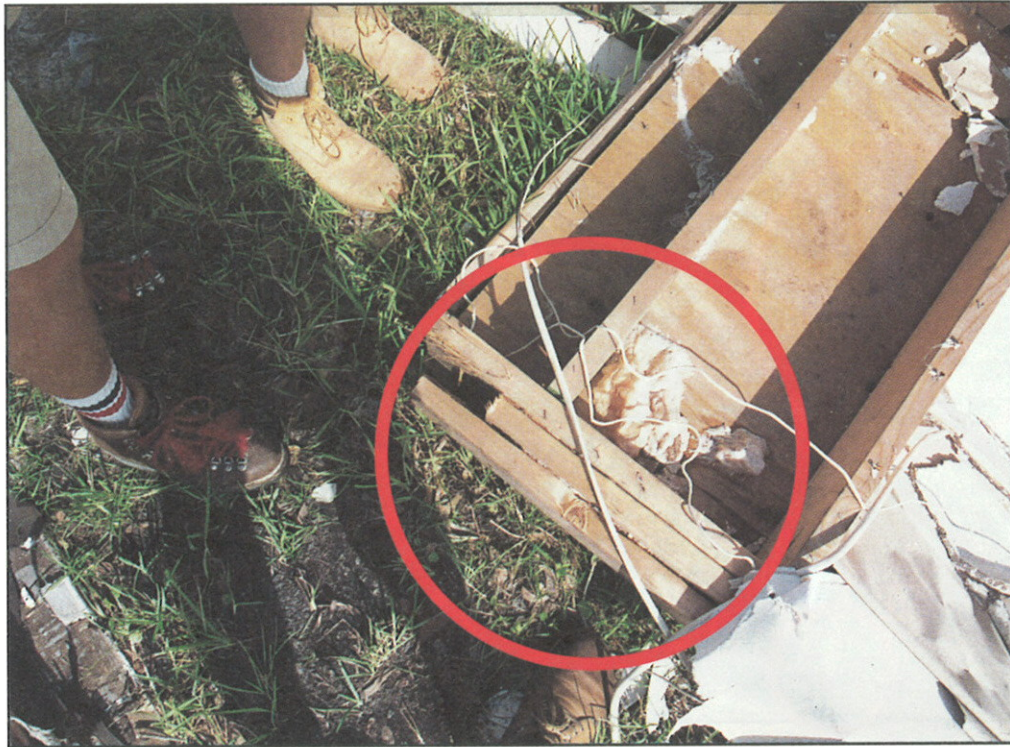
FIGURE 10. *Top plate splice not able to transfer horizontal loads.*

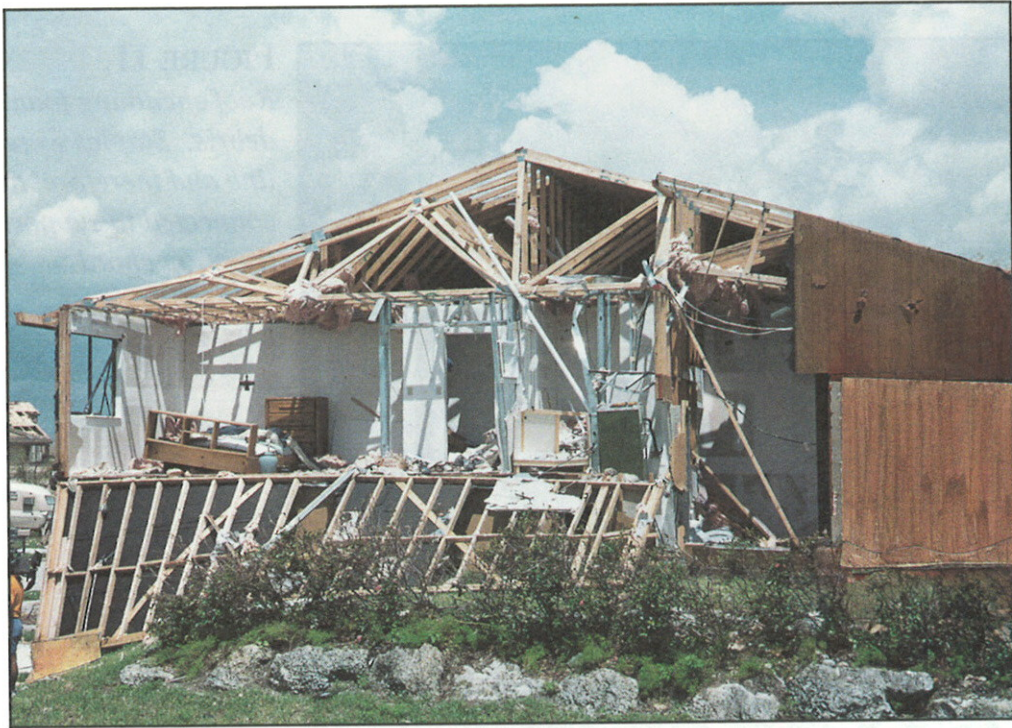
The lack of adequate truss bridging, improper system-wide lateral bracing, inadequate cross-bracing at end trusses, and the lack of stiffening of gable ends were determined to have compromised the integrity of the structural roof systems. It is the opinion of the assessment team that reliance on sheathing for truss-roof bracing, and the corresponding loss of the sheathing, was a major cause of the total damage of the building systems. (SEE FIGURES 12, 13, AND 14.)

FIGURE 12. *End wall failure of typical first floor masonry/second floor wood-frame building. Truss bridging and lateral bracing, and adequately installed roof sheathing, would have greatly reduced the likelihood of such a failure.*

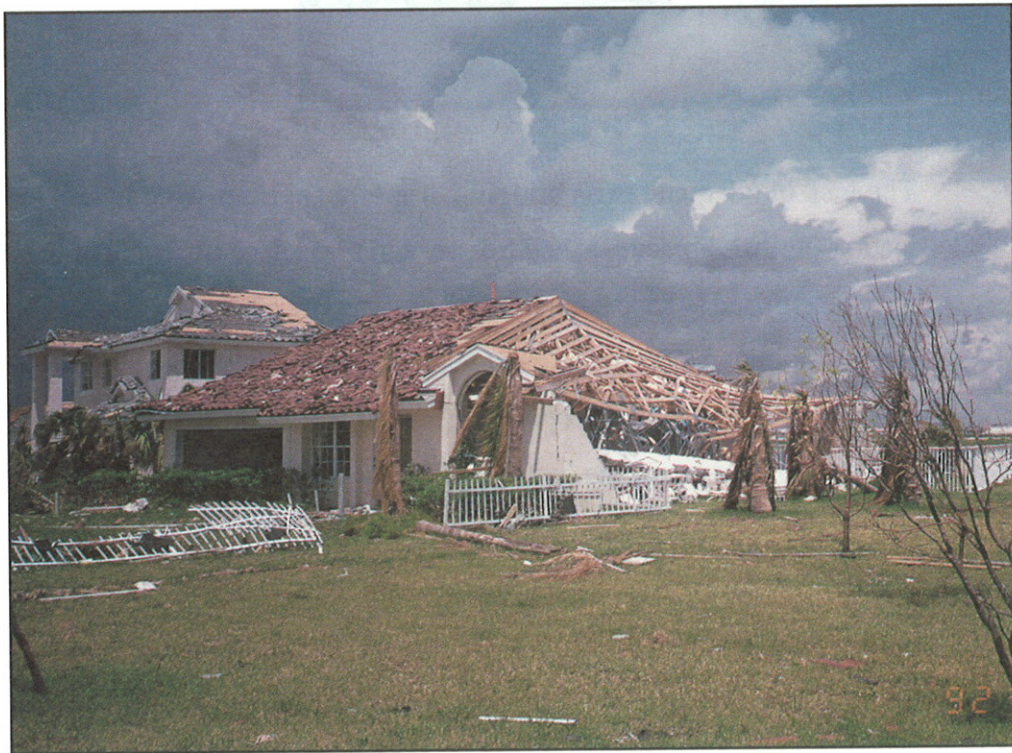
FIGURE 13. *Roof structure failure due to inadequate bracing.*

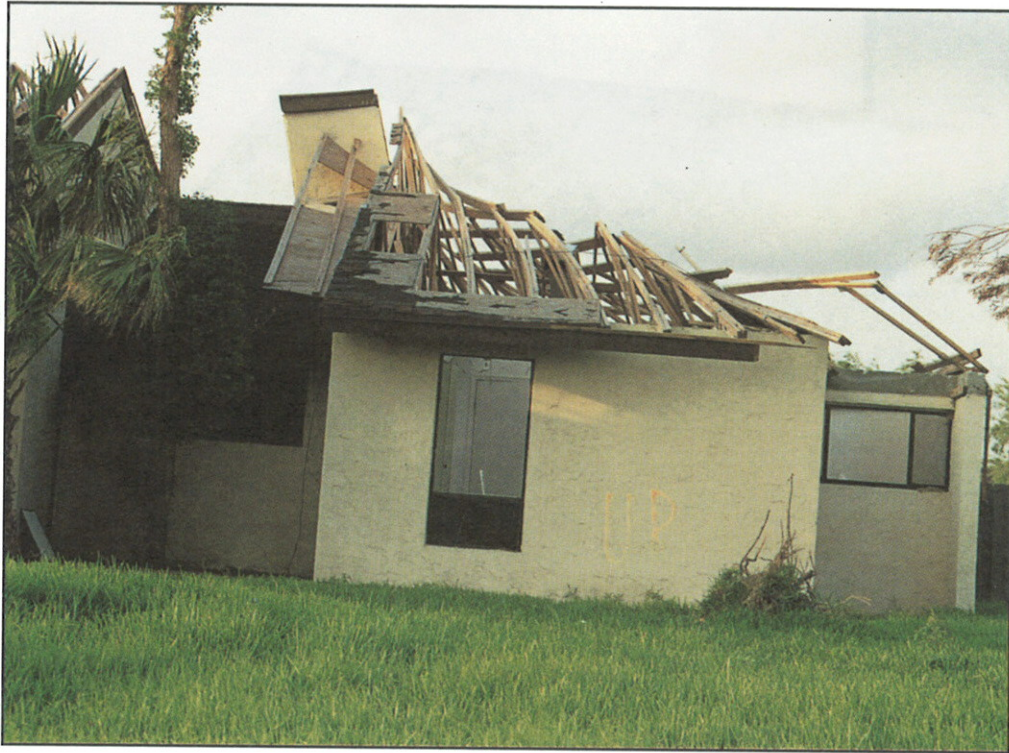
FIGURE 14. *Roof structure failure due to inadequate bracing.*

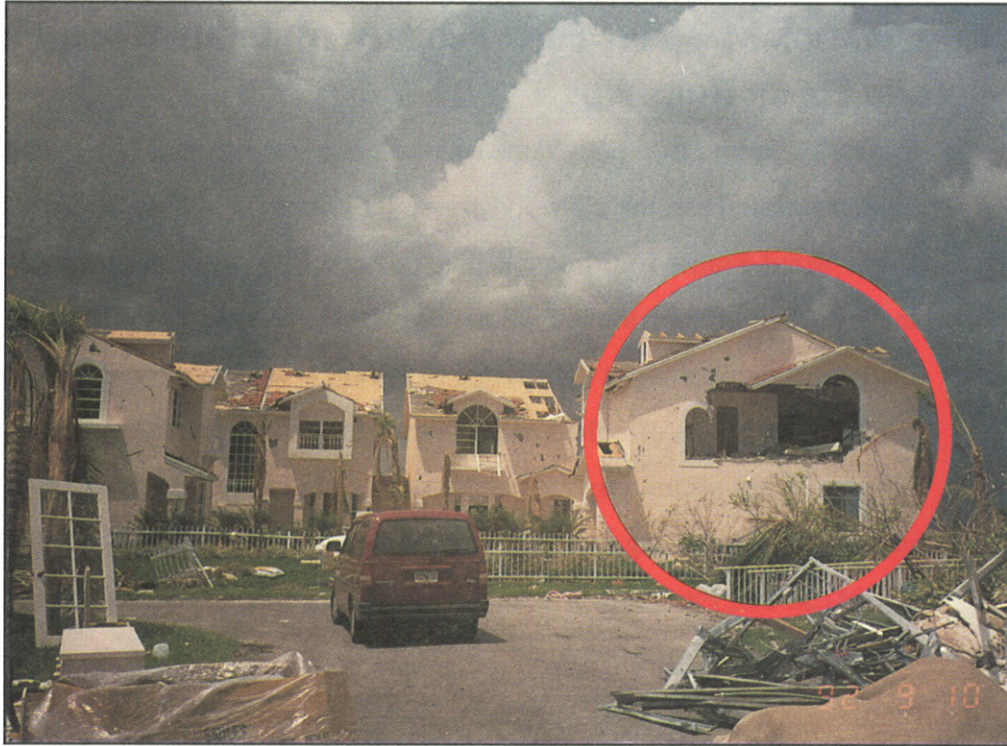
Where failures of the buildings did occur, the following conditions were observed: poor mortar joints between wall and monolithic slab pours; lack of tie-beams (SEE FIGURE 16), horizontal reinforcing, tie columns, and tie-anchors; and misplaced or missing hurricane straps between walls and roof structure.

FIGURE 16. Two-story masonry buildings. Lack of continuous tie-beam led to failure of wall that was already weakened in design by window openings.

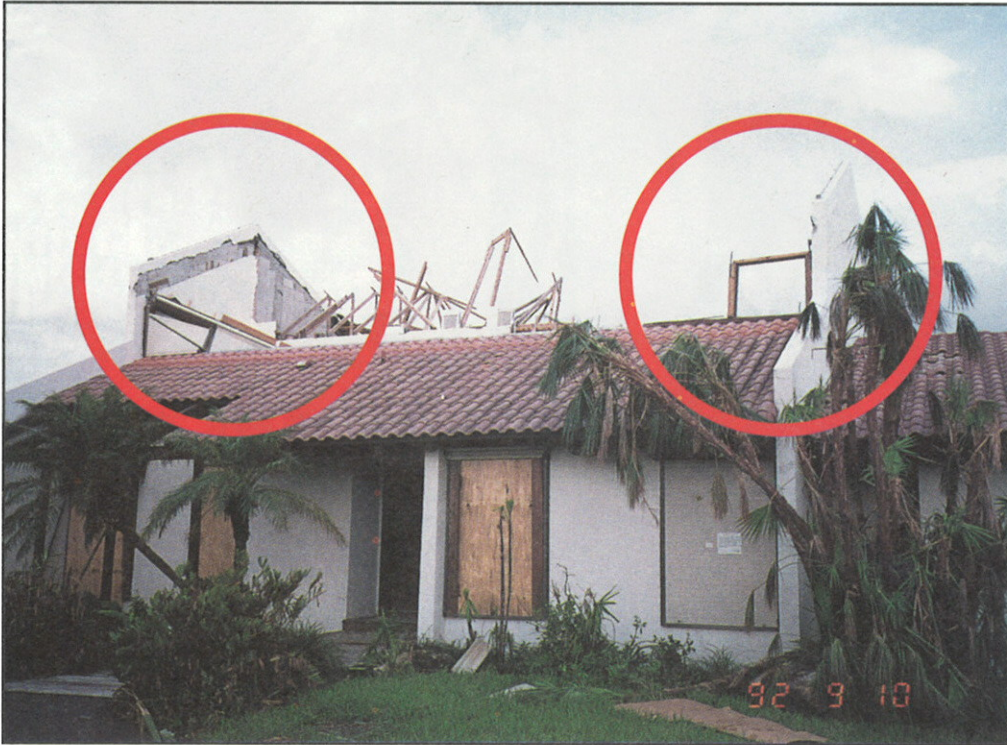
Discontinuous second-story CBS walls (typical firewall design) were prone to failure at their connecting edges and suffered separation from various building envelopes. Improved wall performance through continuous CBS construction was observed in the performance of gable ends that were CBS-constructed (SEE FIGURE 17).

FIGURE 17. Two-story masonry building. While forces were sufficient to blow off entire roof structure, continuous masonry gables held.

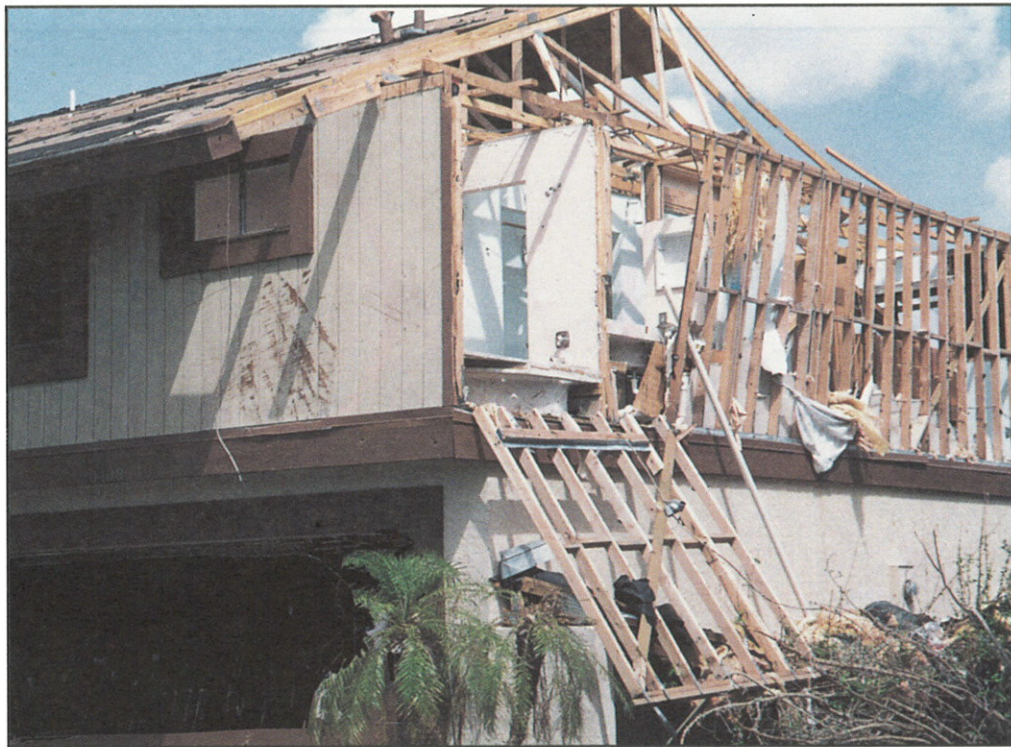
FIGURE 18. *Second story wood framing (on first story masonry). End gable and wall failure.*

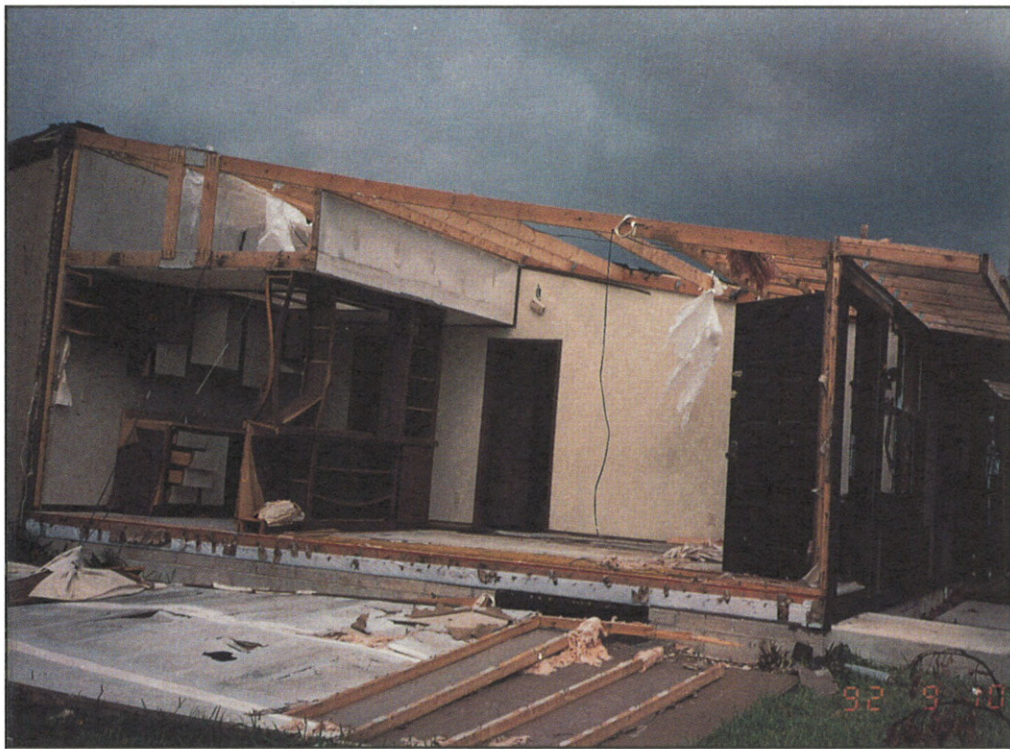
Two end-wall (end wall of end modules) failures were observed in a modular home subdivision. Poor connection of the tops of the walls to the roof diaphragms was evident in these instances. Some roof sheathing was observed missing from rafters, judged to be due either to building envelope breach (window and/or door failure) or to external wind and debris. Generally, the rafters themselves were left entirely intact, because of the inherent rigidity developed by the relatively short spans and secure connections. (SEE FIGURES 19 AND 20.)

FIGURE 19. *Modular home. End wall of end unit separated from unit; withdrawal of nails along eave line and roof sheathing failure were also observed.*

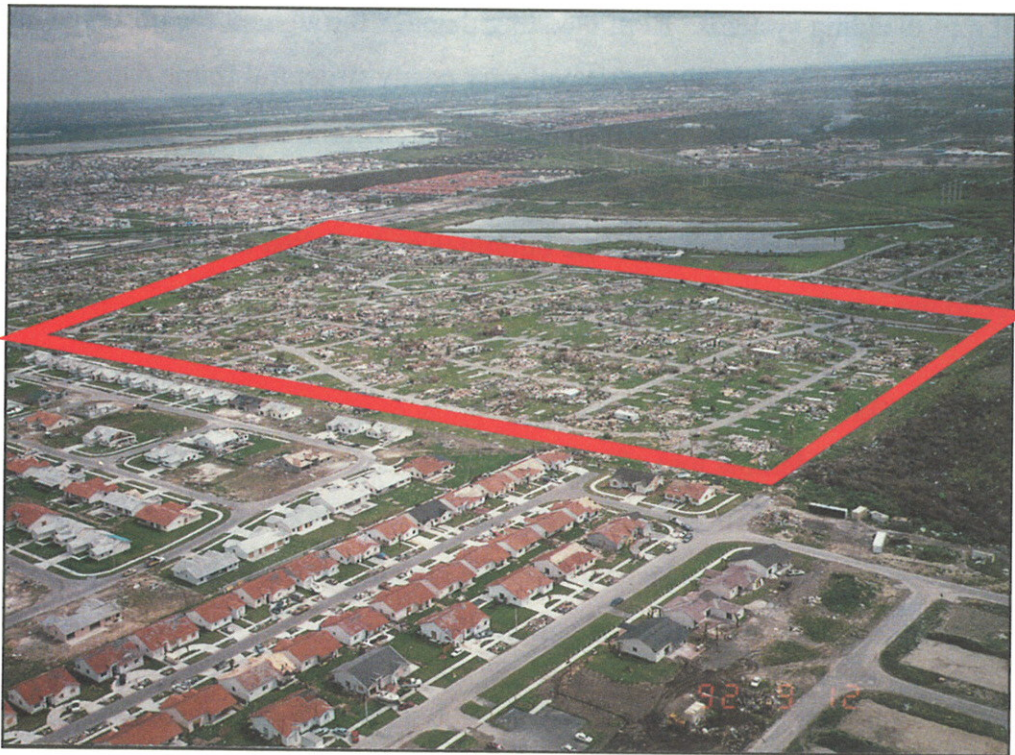
FIGURE 21. Aerial photo of damage area. Shows building performance difference between manufactured homes (outlined in center) and conventional residential buildings (lower left).

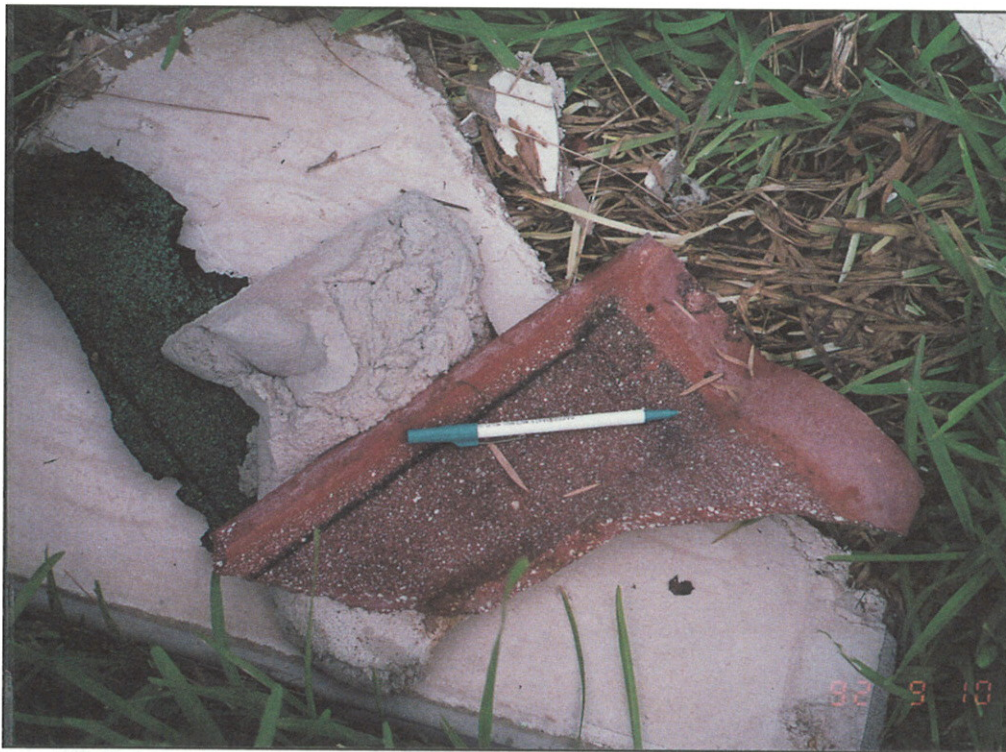
FIGURE 22. *Typical failure of roof sheathing-to-underlayment attachment. (Bond between underlayment and mortar pad, and between mortar pad and tile effective.)*

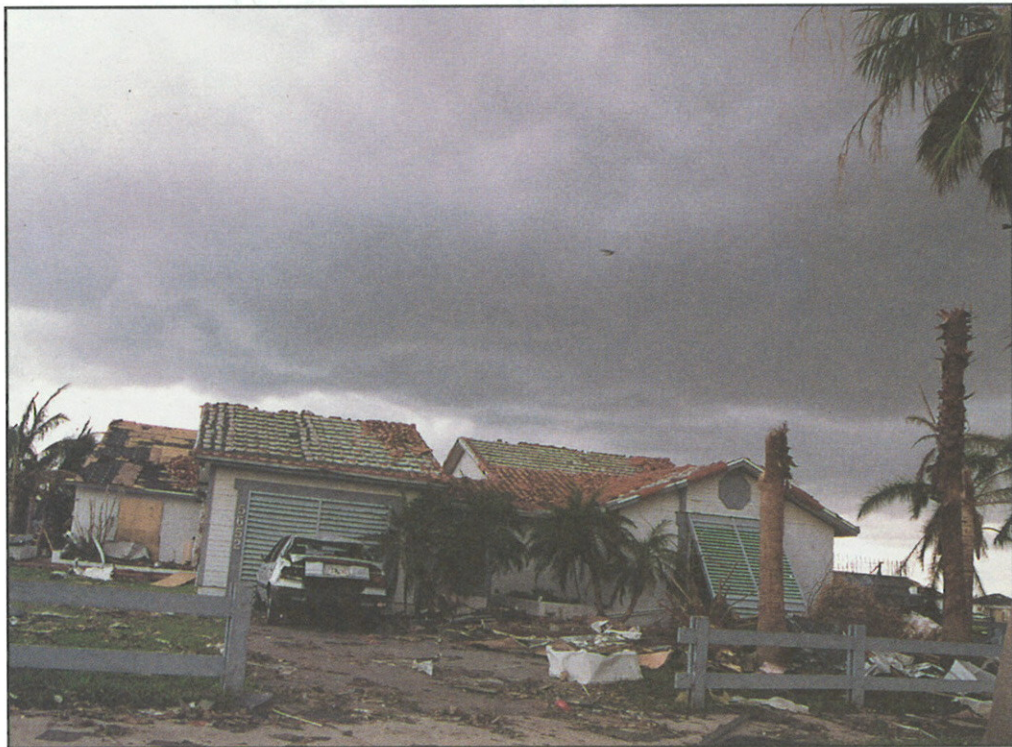
FIGURE 24. *Typical roofing failure. Failure between tiles and mortar pads.*

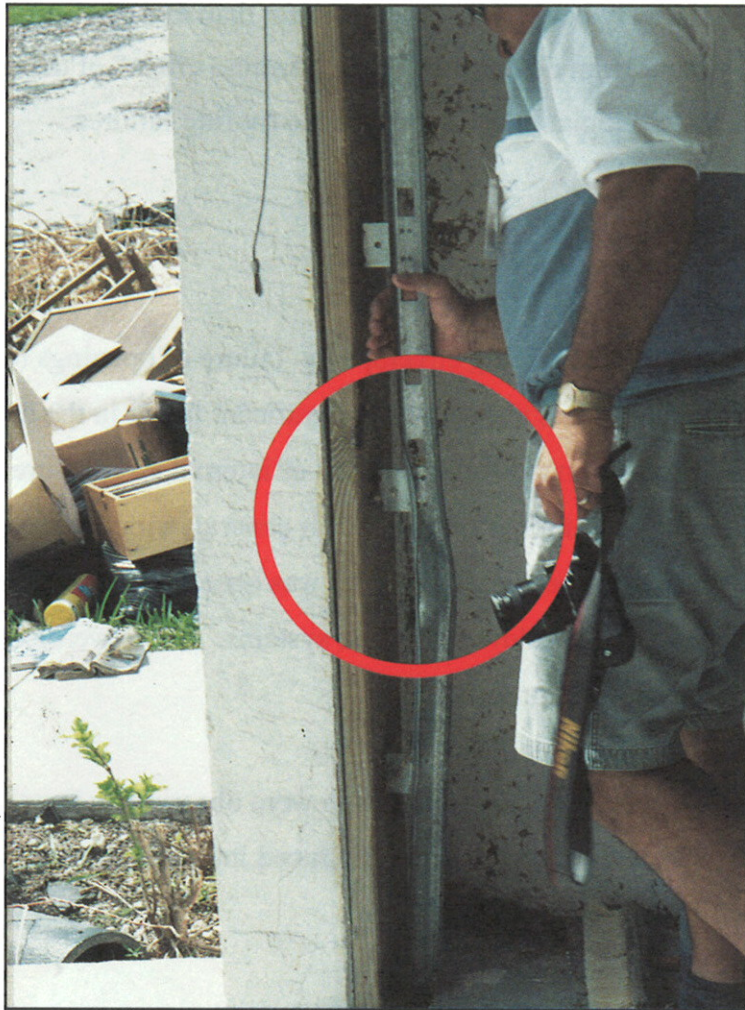
FIGURE 25. *Garage door failure. Rotation of track, and pullout of brackets at wall support.*

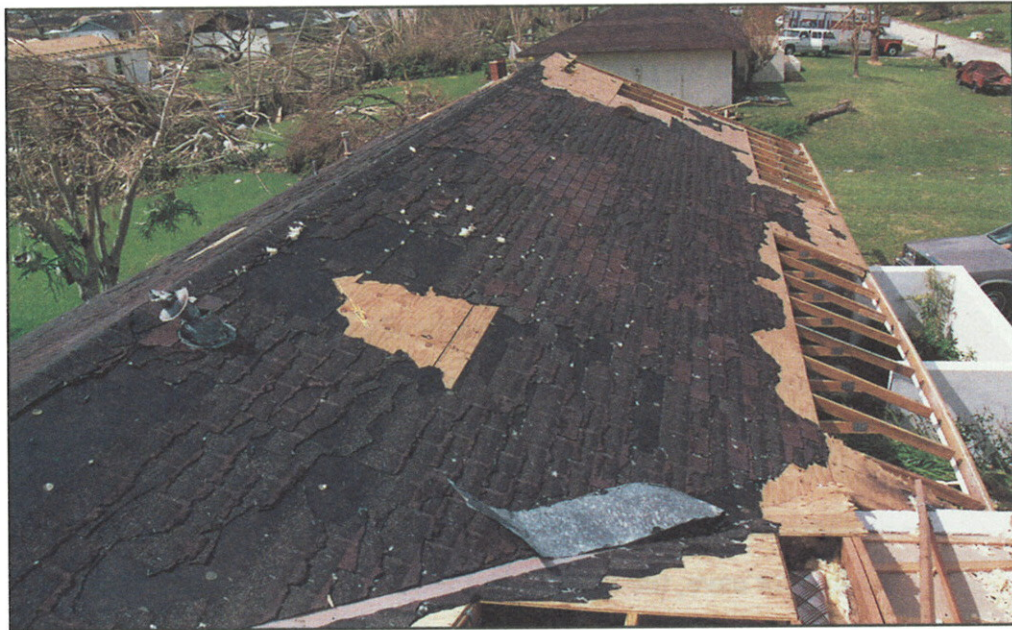
FIGURE 30. *Composition shingle and underlayment failure.*

2. Composition shingles should be manufactured and rated as satisfactory for high-wind areas. In the absence of this, a water-resistant membrane, e.g., a hot-mopped underlayment, should be installed to provide protection from the water infiltration that may result from the loss of roofing material during high-wind storms (SEE FIGURES 30 AND 31).
3. Manufacturers of roof tile products should provide testing and verification of tile performances under realistic conditions (as addressed by the Code).
 - Manufactures should verify that mortar used with extruded concrete tiles can be installed to Code requirements.

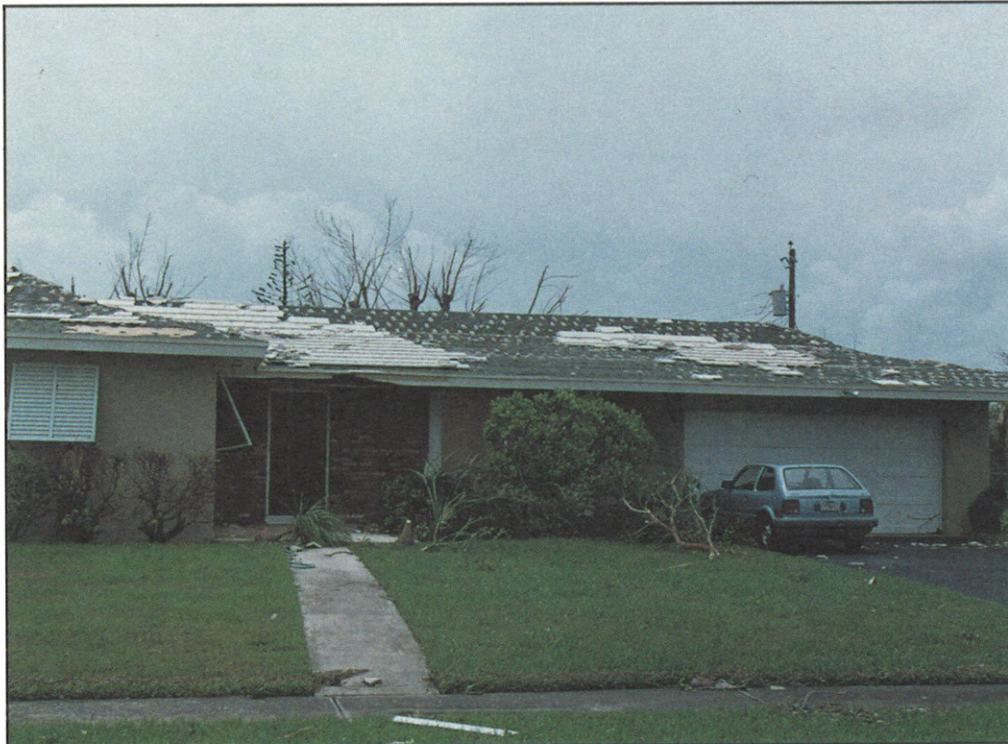
FIGURE 32. *Failure of extruded concrete flat tile roofing. Bond failure between tile and mortar and between mortar and underlayment was observed.*

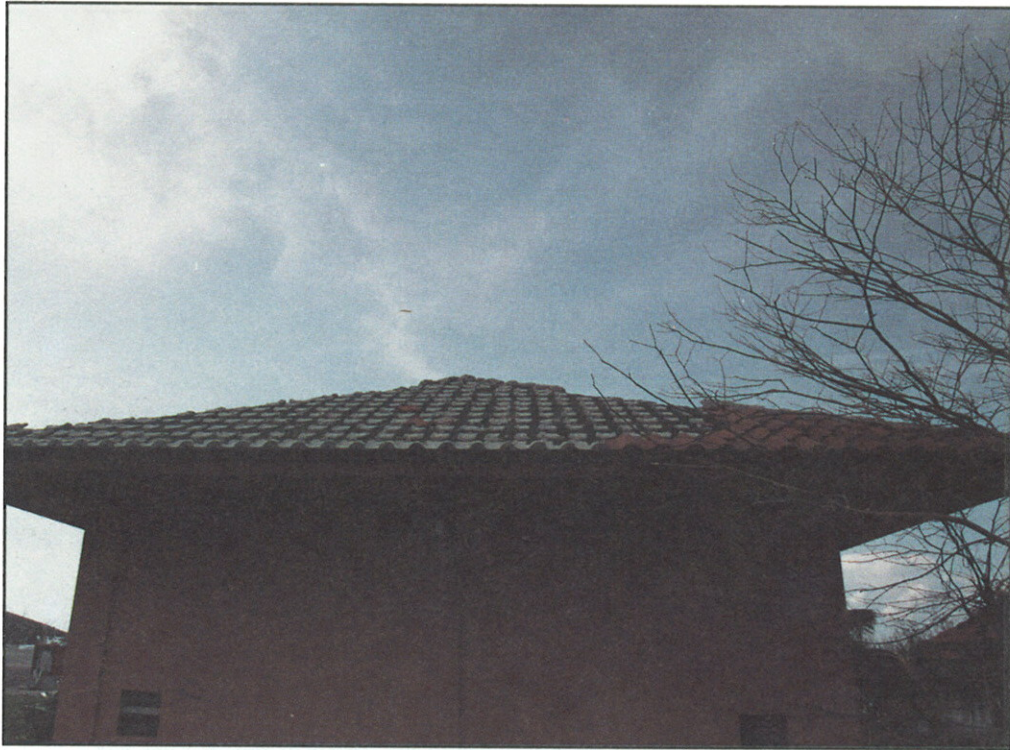
FIGURE 34. Failure of "S" tile roofing. Bond failure between mortar and tile was observed.

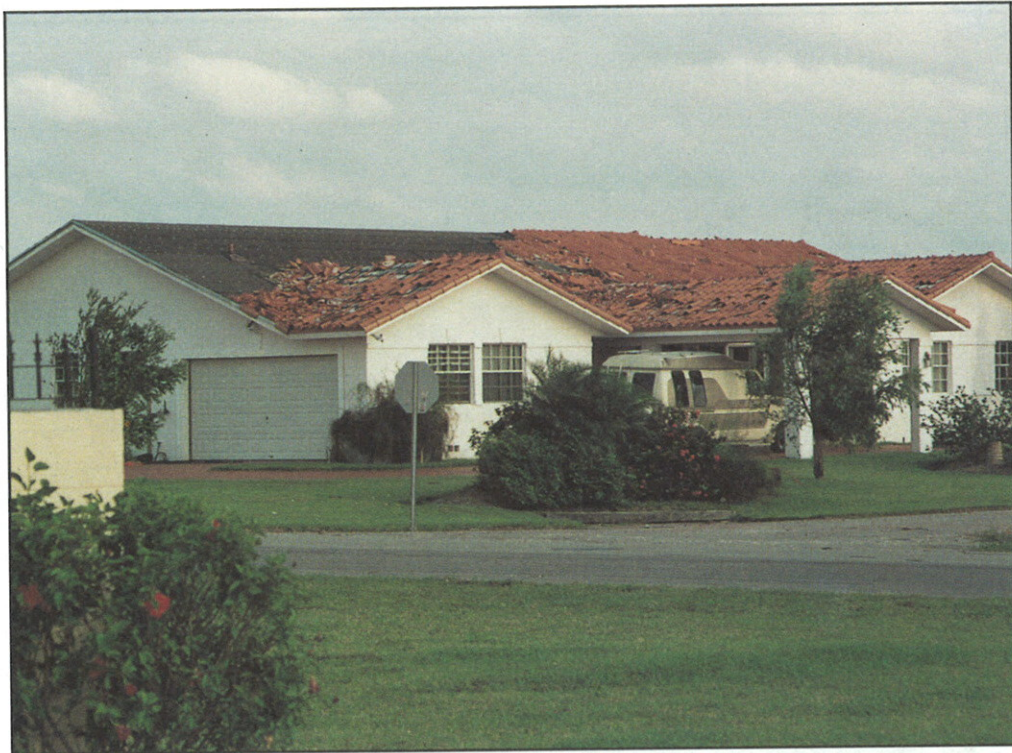
FIGURE 36. *Failure of barrel tile roofing. Bond failure between underlayment and mortar and between mortar and tile was observed.*

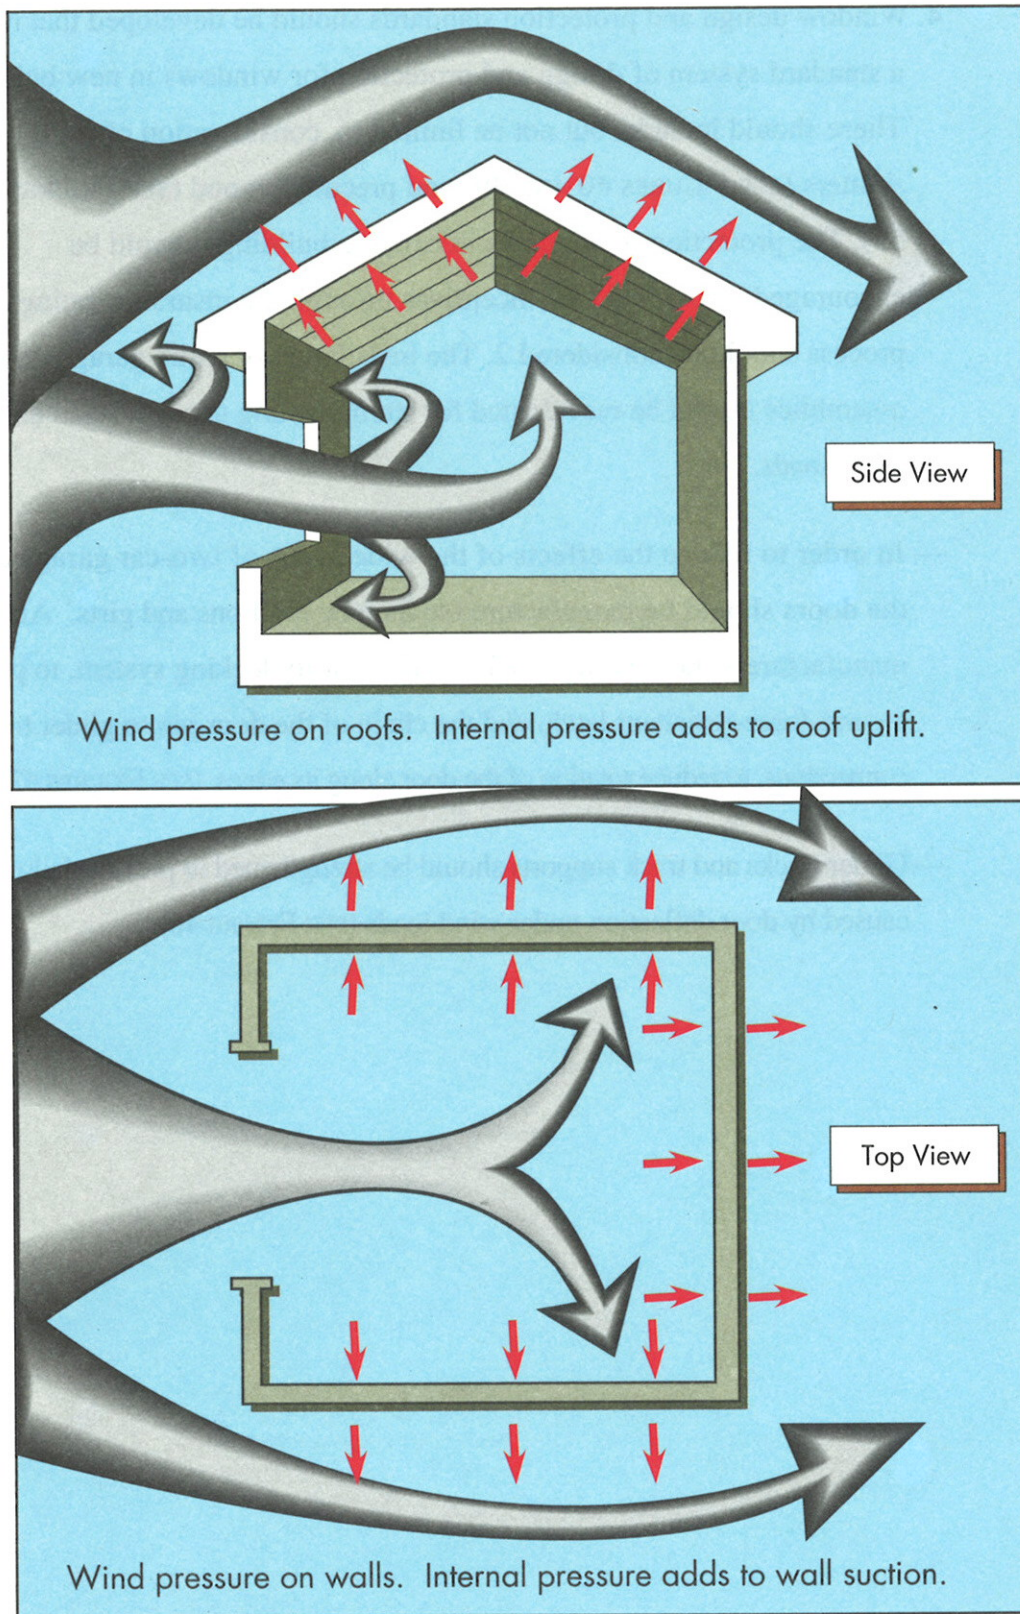
FIGURE 41. Results of building envelope breach due to failure of external doors and windows.

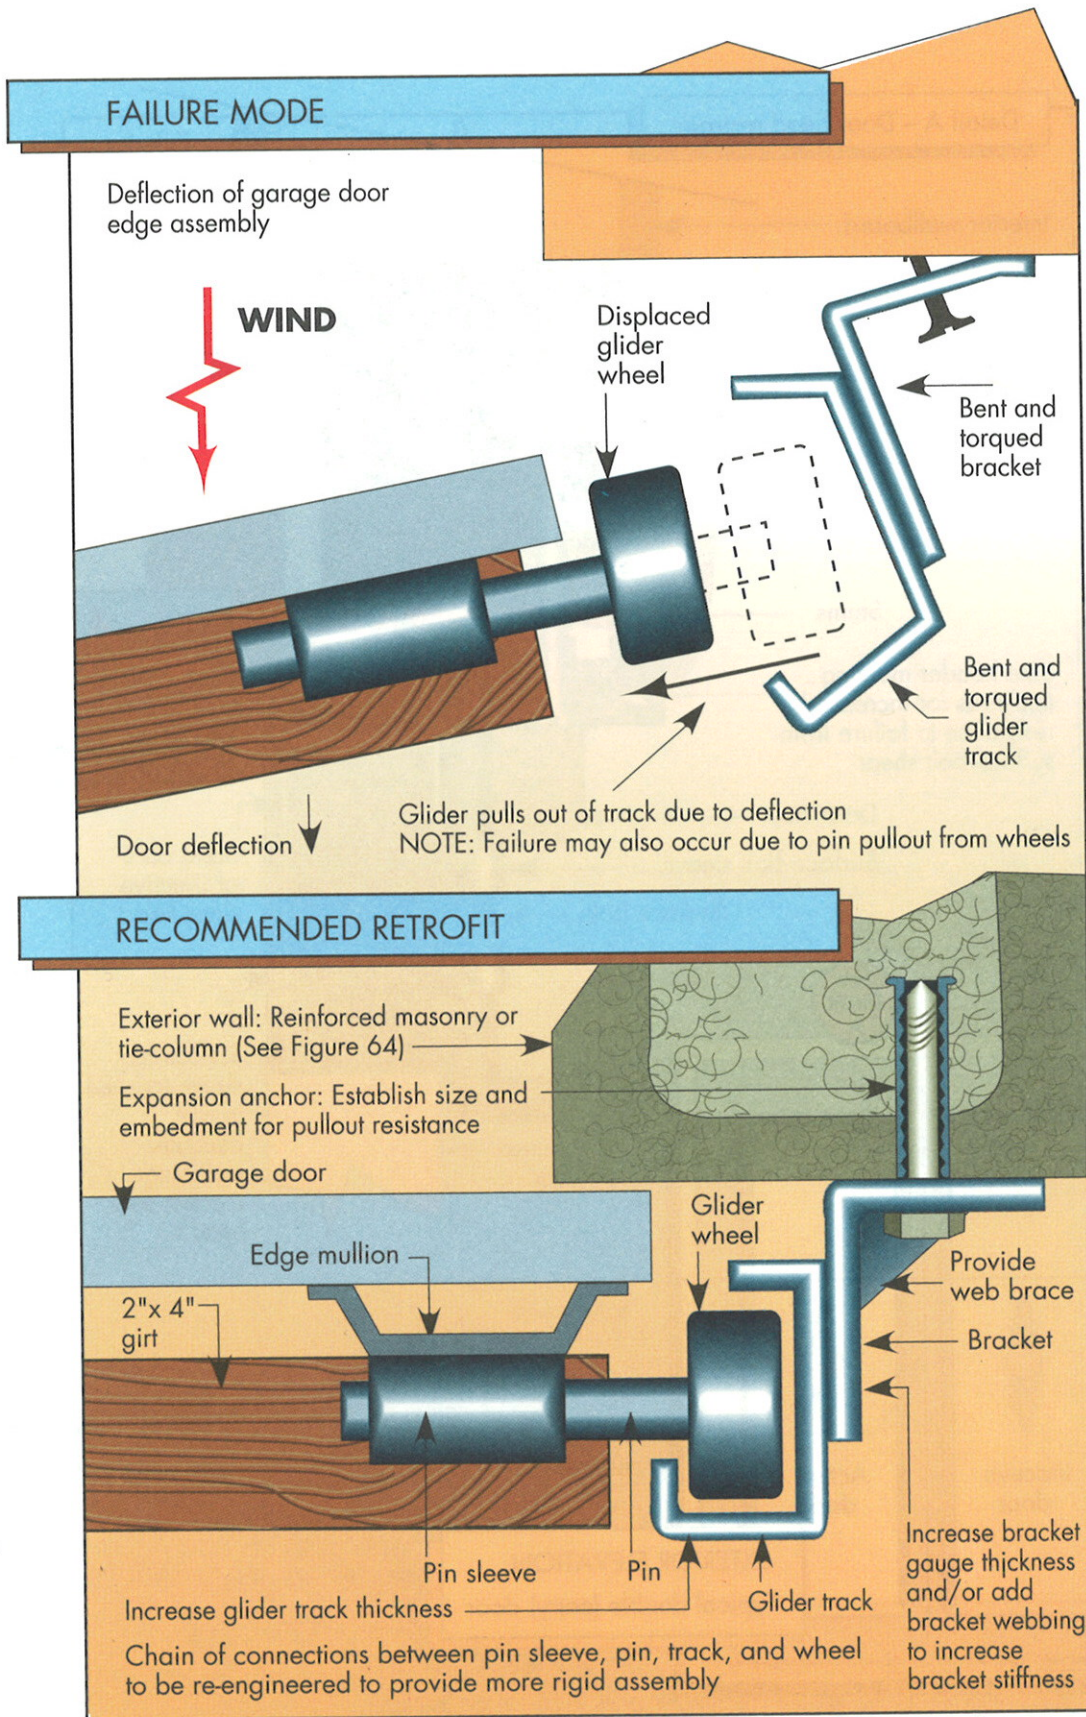
FIGURE 46. Detail B—Garage door failure at edge and recommended assembly improvements.

- Glider tracks and track supports should be strengthened to prevent failure caused by door deflection under wind loads (SEE FIGURE 46).

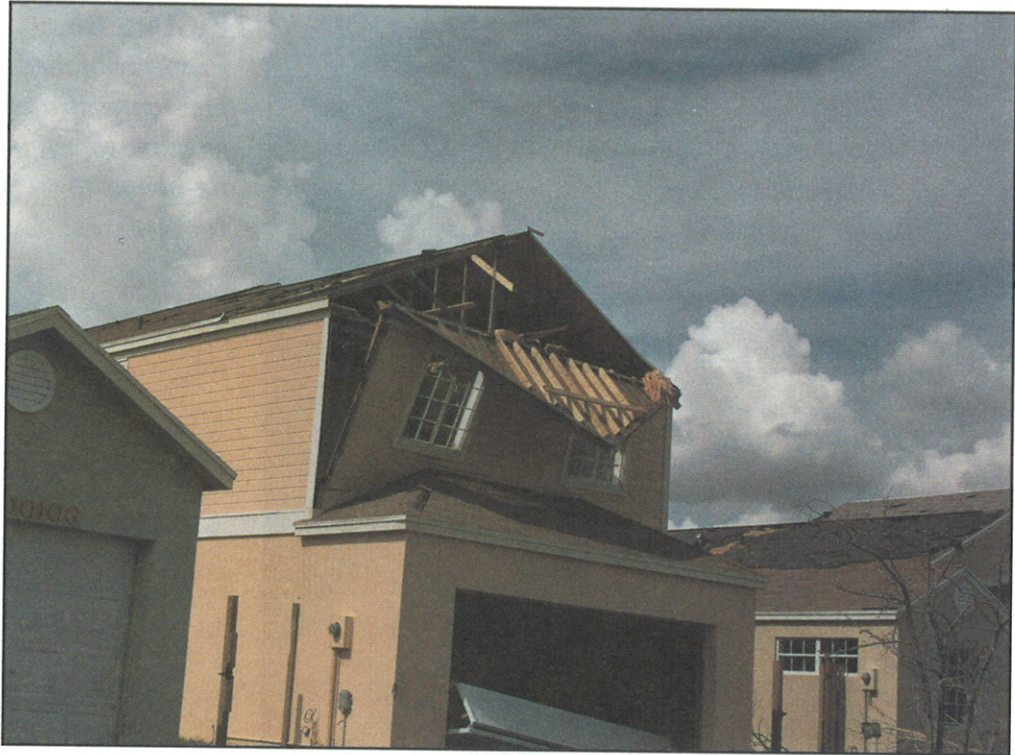
FIGURE 58. *End wall failure. Example of lack of load transfer capacity after separation.*

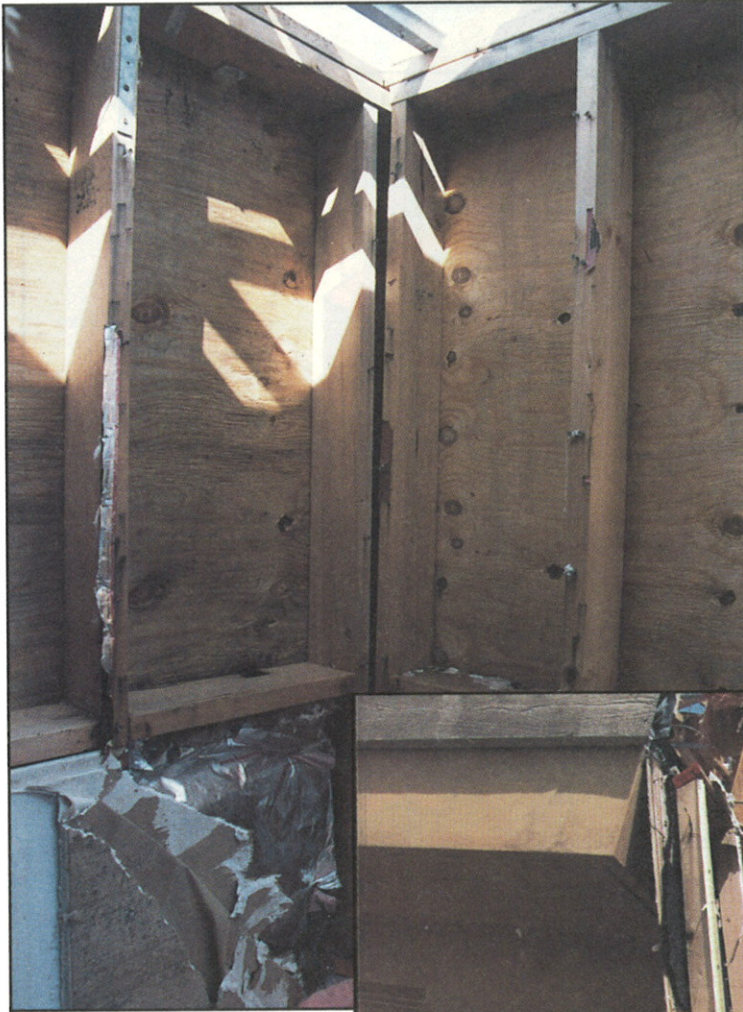
FIGURE 59.
*End column/corner post
missing from
wall.*

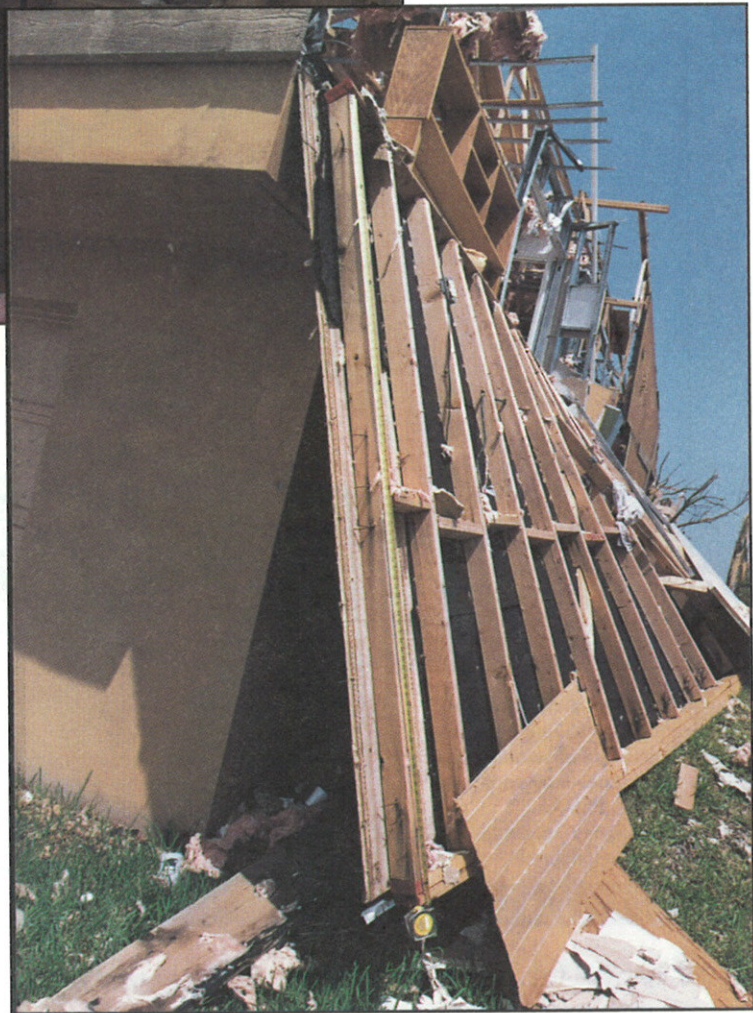
FIGURE 60.
*Side wall failure. Side
wall has no lateral load
transfer capacity due to
inadequately built-up
corner post.*

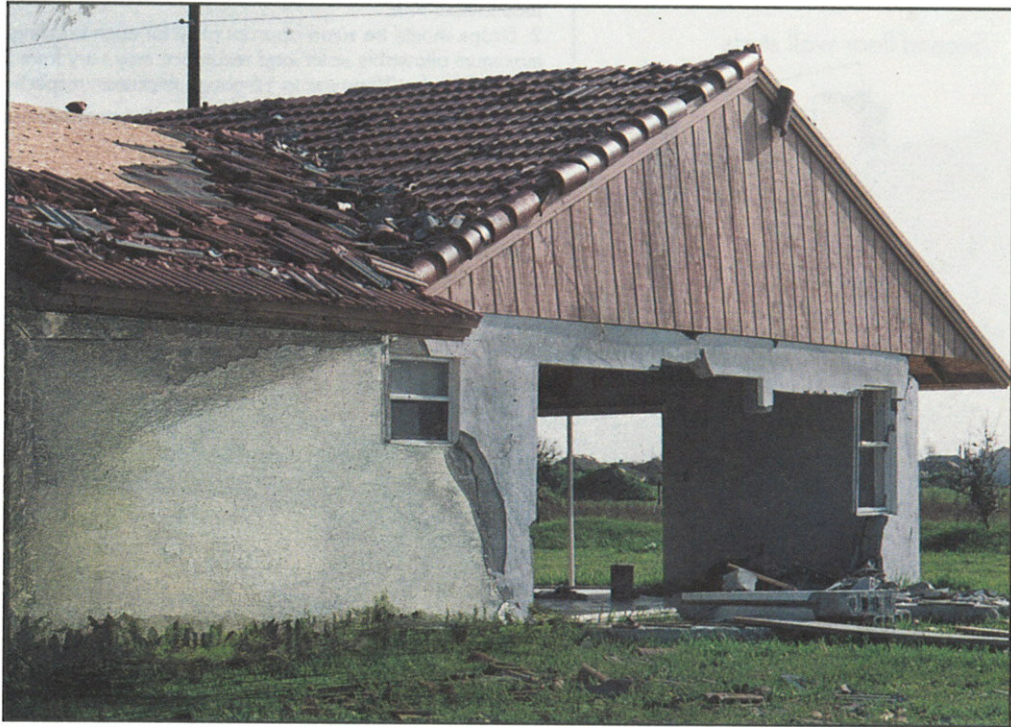
FIGURE 63. *Example of masonry construction. Wall separated from building envelope due to inadequate vertical wall reinforcing in connection to horizontal tie-beam.*

— The Code requirements for tie-beams/tie-columns, or alternative reinforced masonry construction, should be reviewed and enforced (SEE FIGURES 63 AND 64).

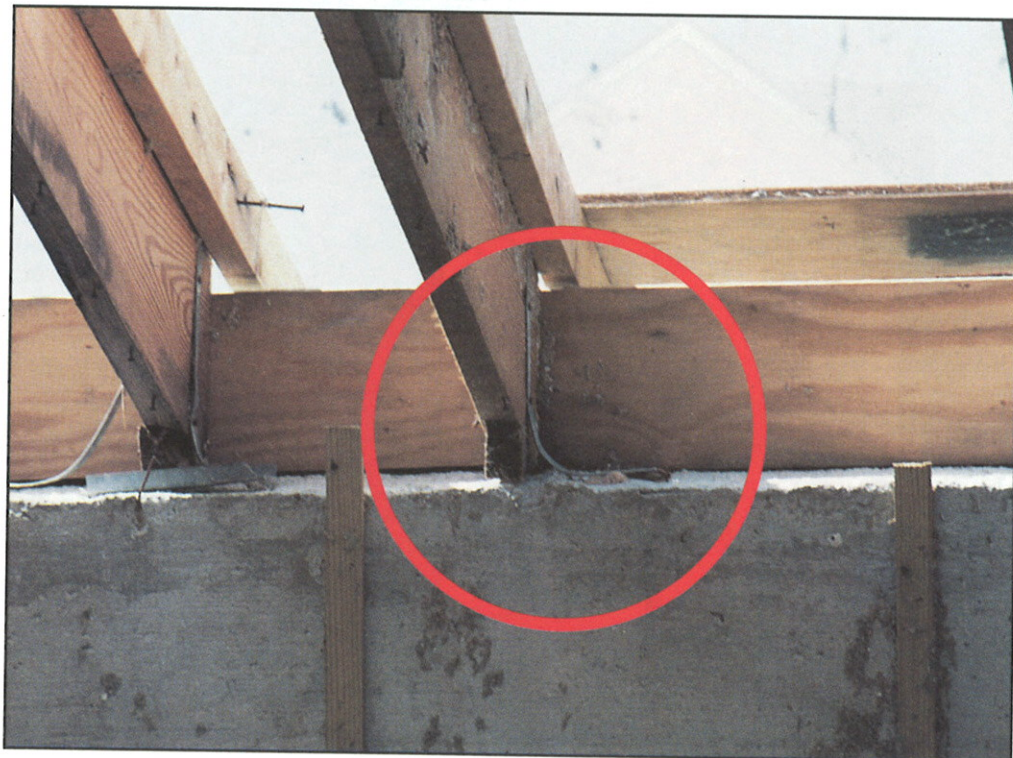
FIGURE 70. Improperly located masonry-wall-to-wood-frame straps.
