BUILDING PERFORMANCE: HURRICANE ANDREW IN FLORIDA

OBSERVATIONS, RECOMMENDATIONS,
AND TECHNICAL GUIDANCE

FEDERAL EMERGENCY MANAGEMENT AGENCY
FEDERAL INSURANCE ADMINISTRATION

DECEMBER 21, 1992

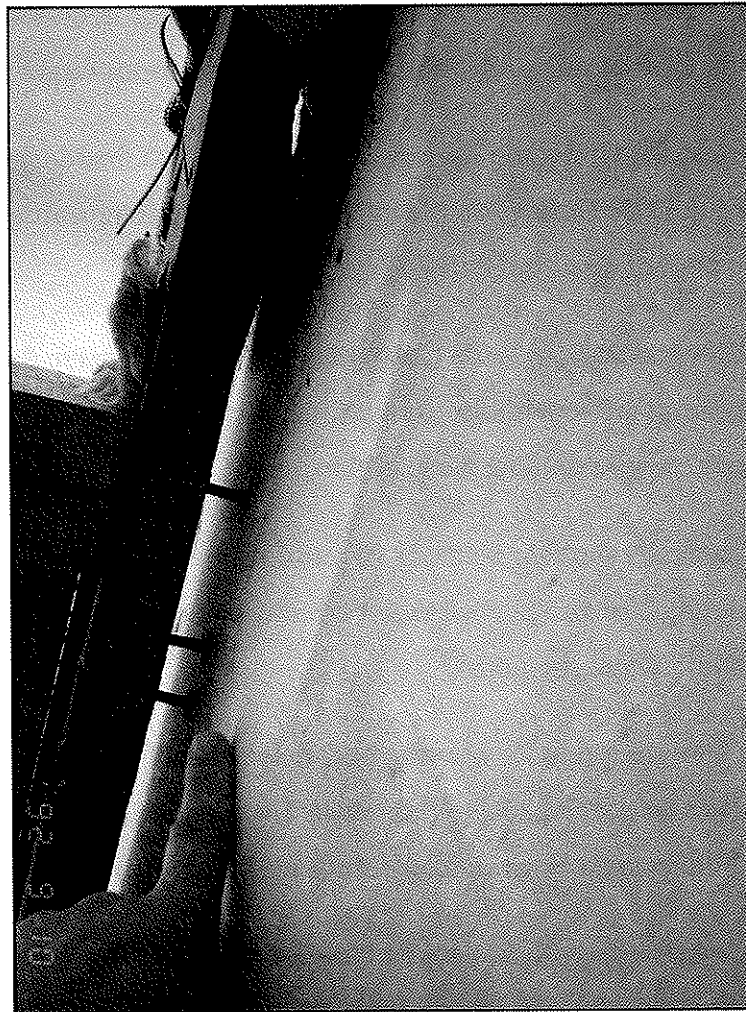
FIGURE 71. *Modular home. Partial separation of end panel (right) from roof structure (left). Evidence of failure due to nail withdrawal.*
