BUILDING PERFORMANCE: HURRICANE ANDREW IN FLORIDA

OBSERVATIONS, RECOMMENDATIONS,
AND TECHNICAL GUIDANCE

FEDERAL EMERGENCY MANAGEMENT AGENCY
FEDERAL INSURANCE ADMINISTRATION

DECEMBER 21, 1992

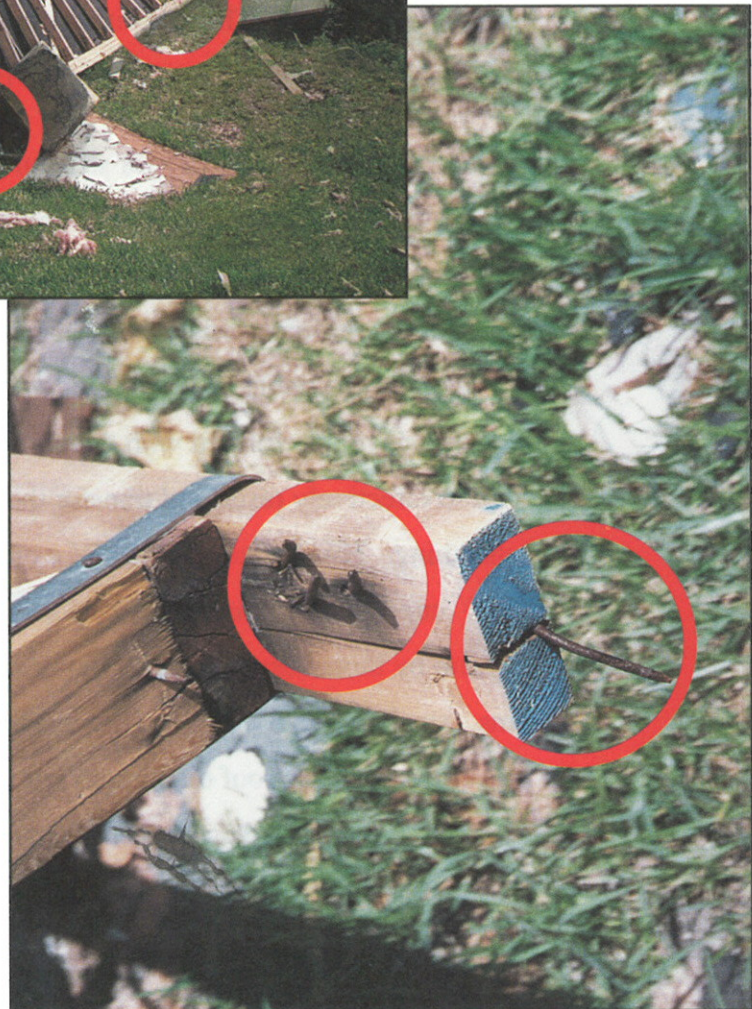
An absence of or improper installation of framing connections, load transfer straps, or bracing from non-loadbearing walls to connecting wall and roof components was noted. This condition contributed significantly to the primary failure of the framing system (SEE FIGURES 4 AND 5).

FIGURE 4.
Exterior wood-frame non-loadbearing wall. Transfer of wind forces from wall to adjoining structure was not sufficient.

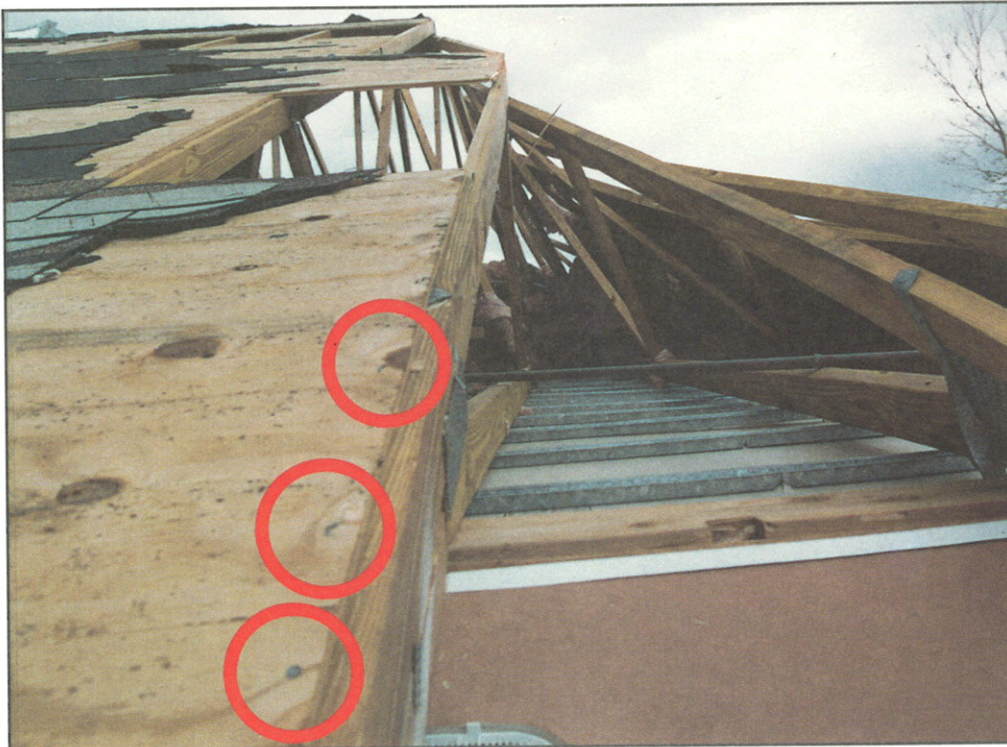
FIGURE 57. *Sheathing only tack-nailed.*

1. Designers and plan reviewers should pay greater attention to lateral load transfer mechanisms because of high lateral loads generated by hurricane winds (SEE FIGURES 9, 10, AND 54-58).
 2. At the construction stage, greater attention must be paid to the proper installation of all lateral load transfer mechanisms inherent in conventional building framing, especially hurricane straps and clips (SEE FIGURES 59-62).
- Manufacturers of metal connectors for wood framing currently provide on-site demonstrations and workshops for training purposes. These workshops should be structured to provide certificates of participation to builders and should be encouraged by the home-buying community.

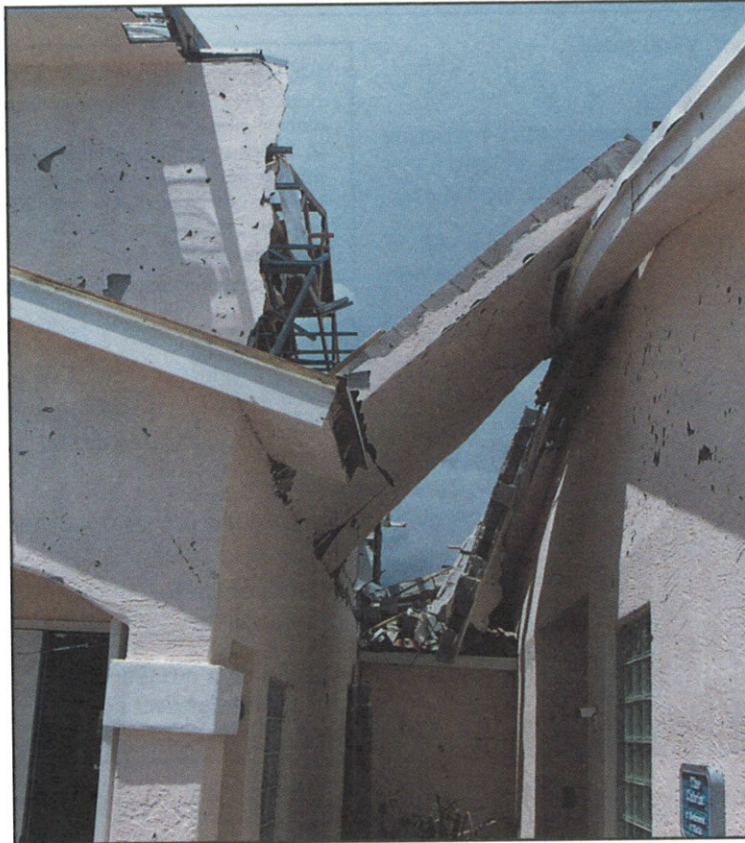
FIGURE 67.
 Firewall separation .
 Results from building
 corners being
 discontinuous with tie-
 beams. (See Figure 68
 for side view)

- Bracing with struts or pilaster columns in walls perpendicular to the freestanding walls, or adequate reinforcing in the walls sufficiently anchored in the foundation or story below, must be engineered and installed.
