BUILDING PERFORMANCE: HURRICANE ANDREW IN FLORIDA

OBSERVATIONS, RECOMMENDATIONS,
AND TECHNICAL GUIDANCE

FEDERAL EMERGENCY MANAGEMENT AGENCY
FEDERAL INSURANCE ADMINISTRATION

DECEMBER 21, 1992

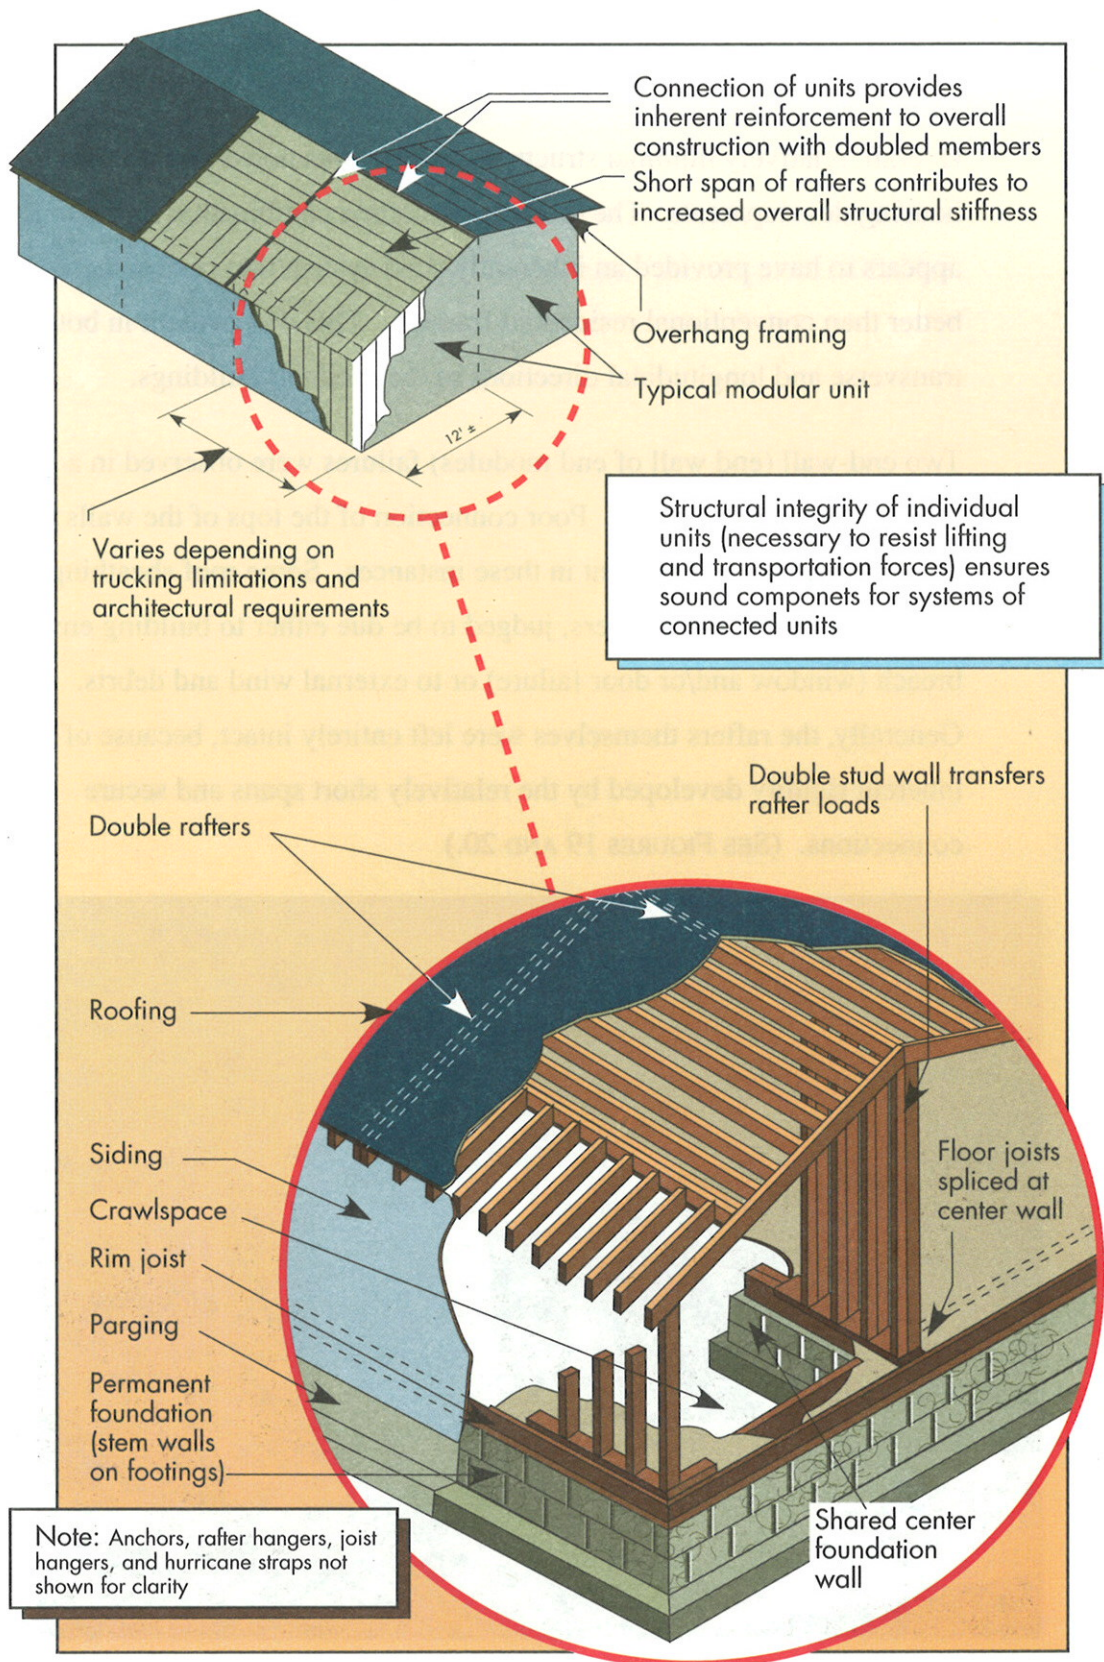
Two end-wall (end wall of end modules) failures were observed in a modular home subdivision. Poor connection of the tops of the walls to the roof diaphragms was evident in these instances. Some roof sheathing was observed missing from rafters, judged to be due either to building envelope breach (window and/or door failure) or to external wind and debris. Generally, the rafters themselves were left entirely intact, because of the inherent rigidity developed by the relatively short spans and secure connections. (SEE FIGURES 19 AND 20.)

FIGURE 20. *Inherent structural strength of modular construction.*

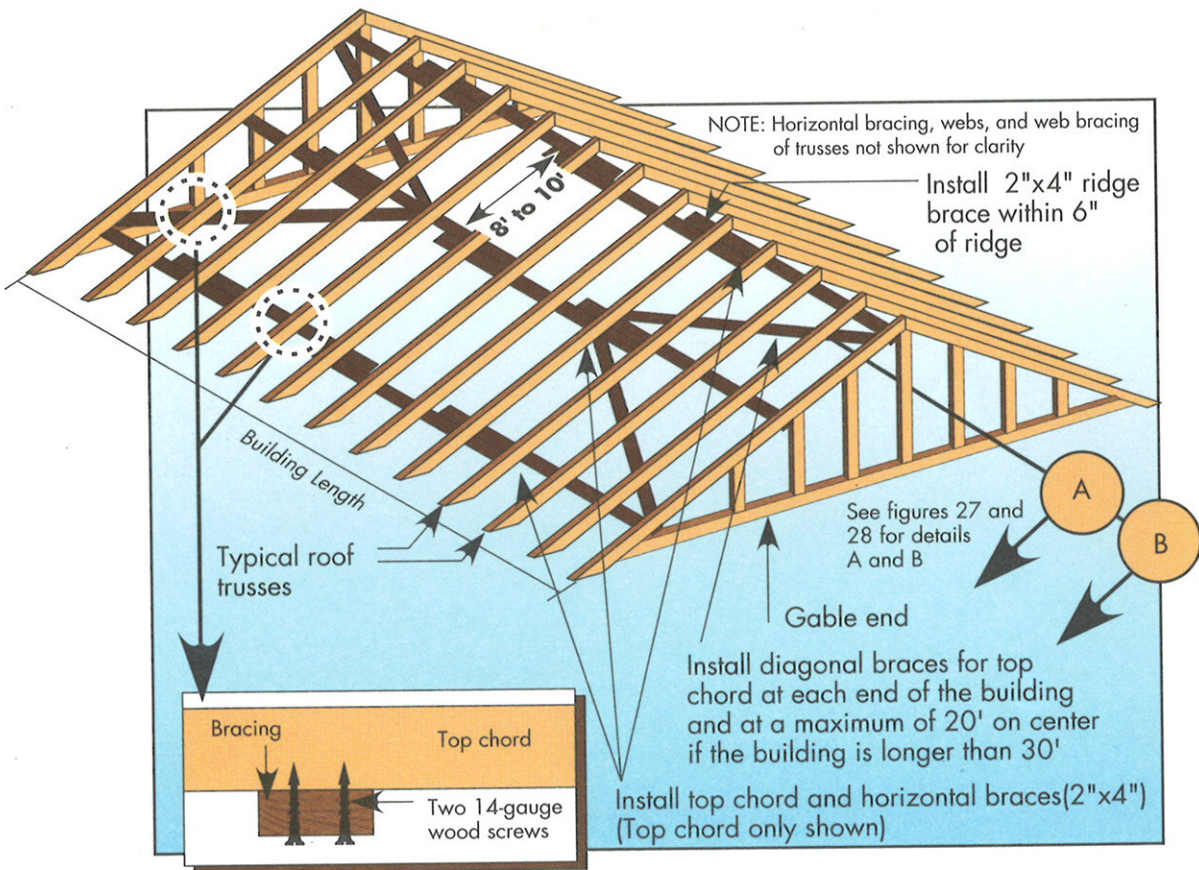
FIGURE 26. Typical roof truss top chord bracing.

1. In addition to the existing program of systematic framing inspections, a specific roof bracing and sheathing inspection should be required prior to installation of roof underlayment (SEE FIGURES 26-29). Note the extra bracing recommended for gable ends in particular.

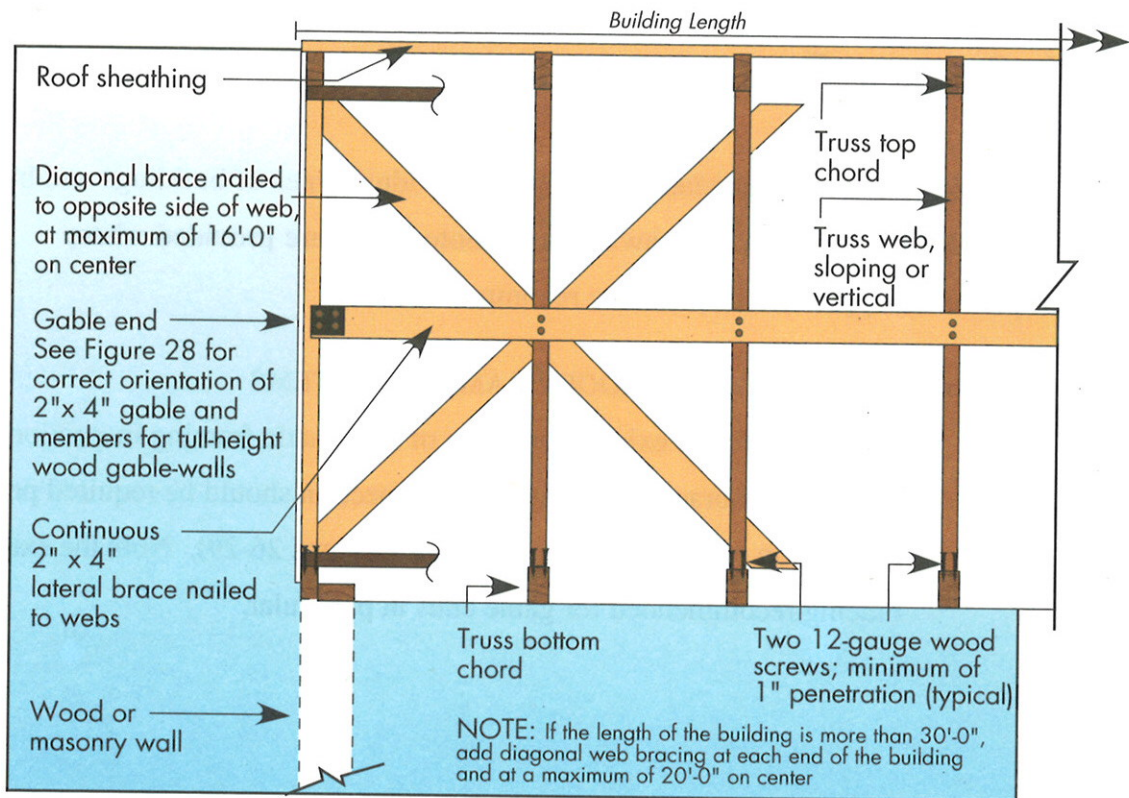
FIGURE 27. Detail A — Typical truss web bracing. Diagonal web bracing as shown, at each gable end of building.

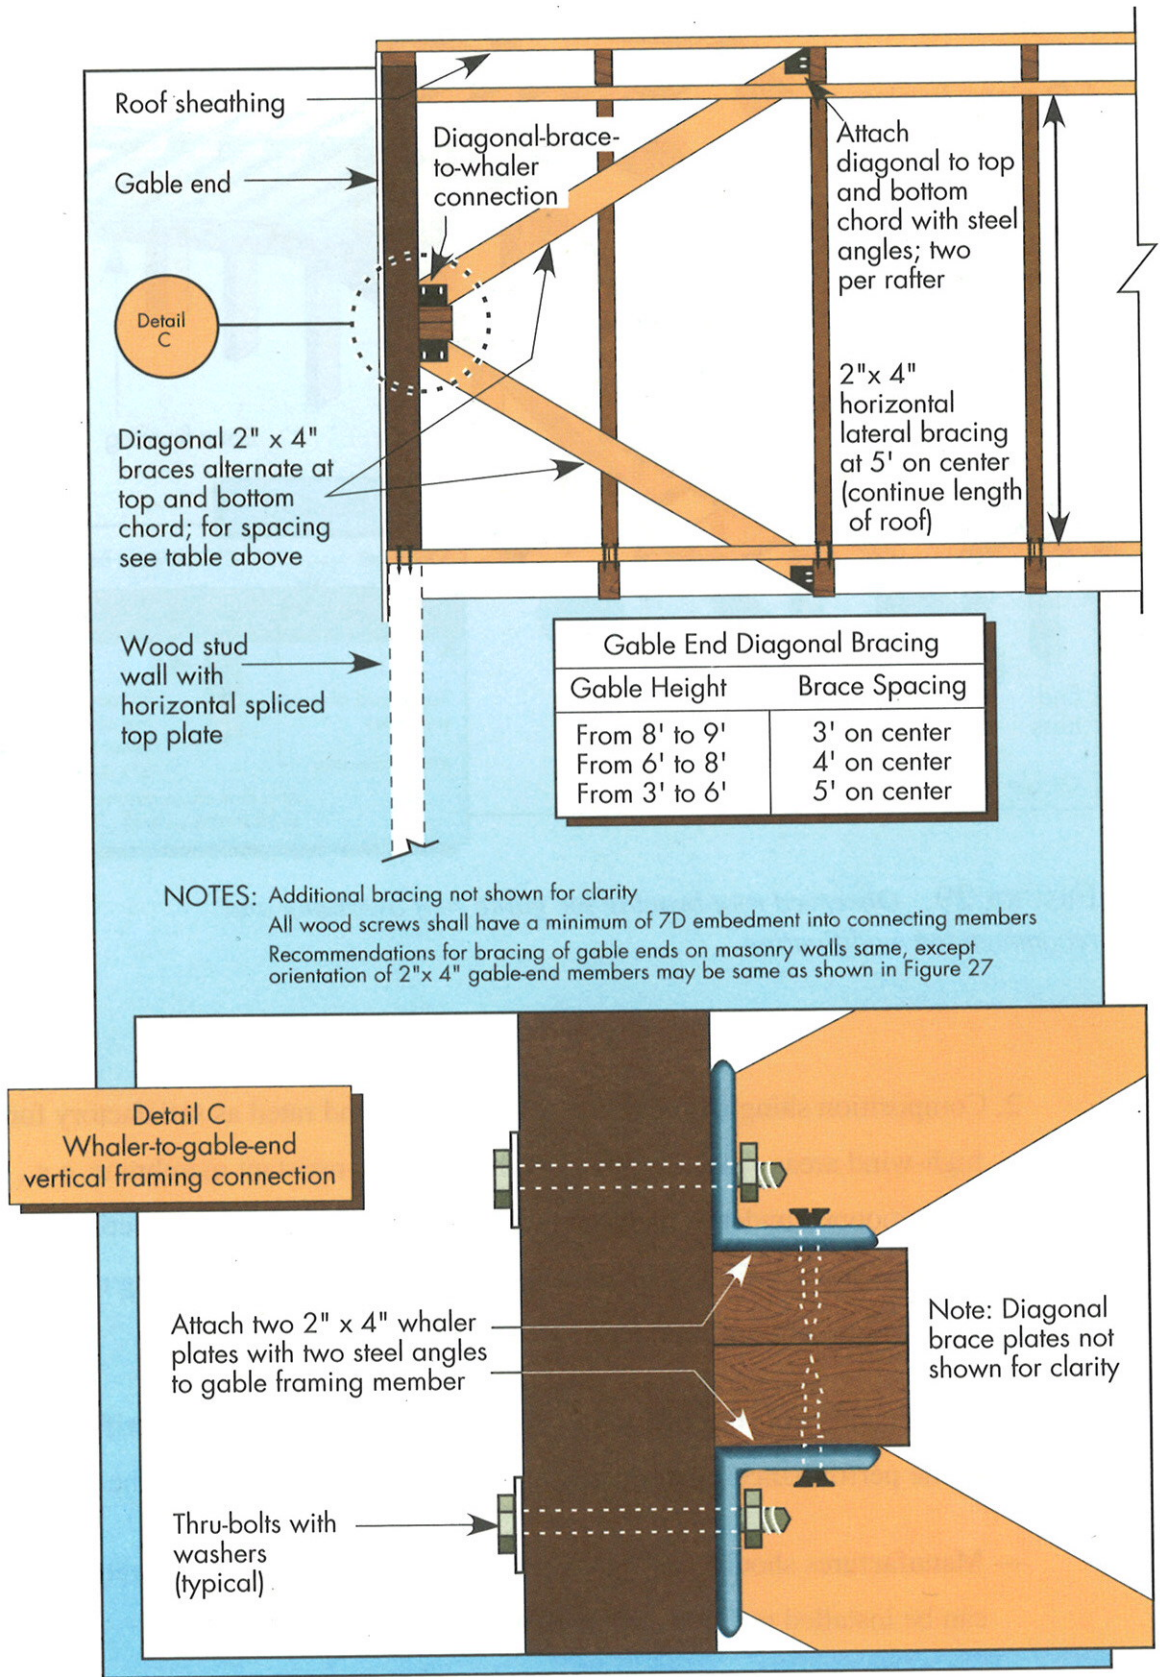
FIGURE 28. Detail B — Typical wood gable-wall bracing.

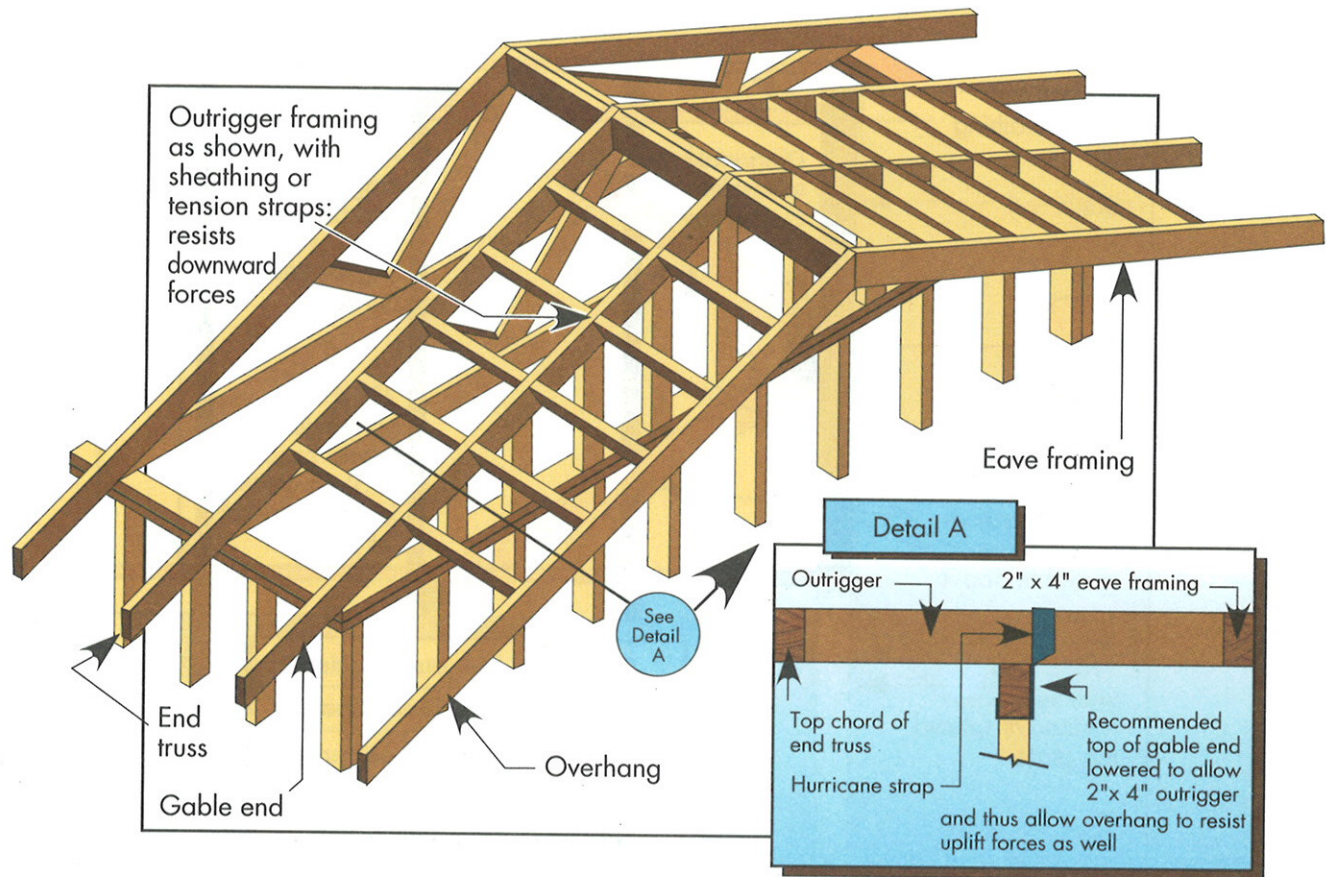
FIGURE 29. Observed roof bracing for gable roof overhang and recommended modification.

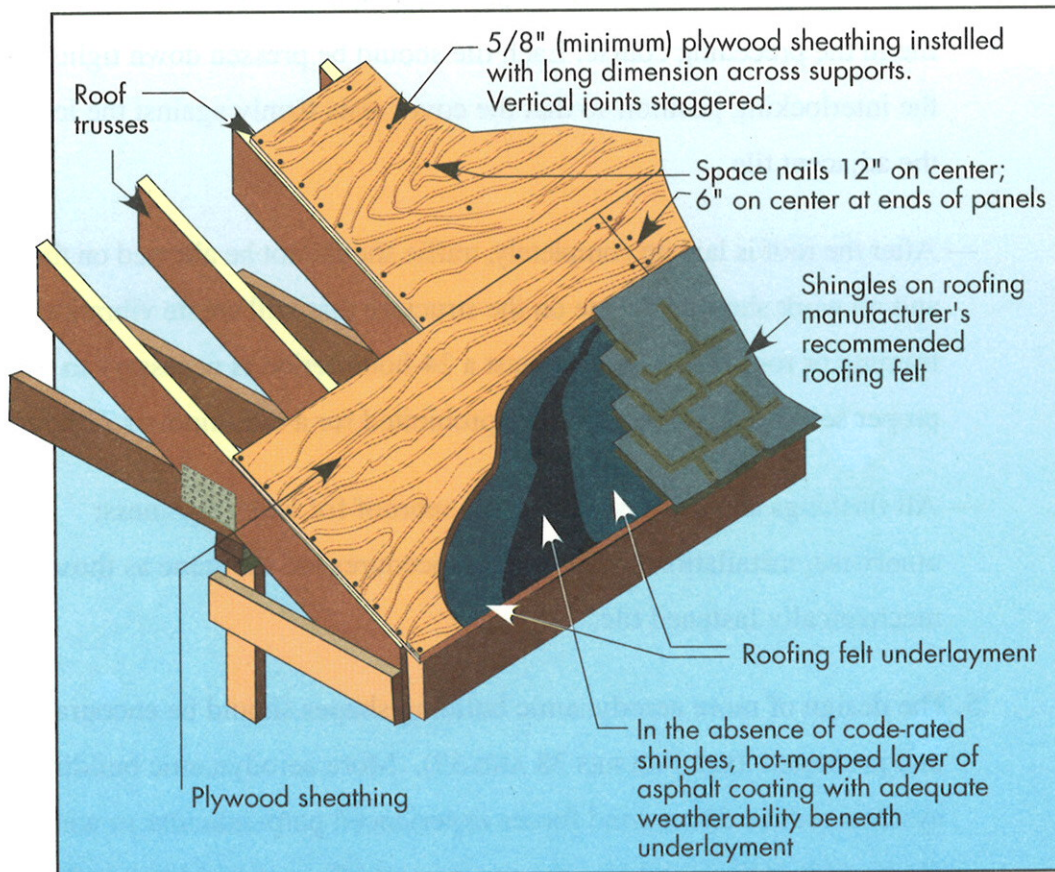
FIGURE 31. *Composition shingle roofing system showing sheathing and hot-mopped underlayment.*

2. Composition shingles should be manufactured and rated as satisfactory for high-wind areas. In the absence of this, a water-resistant membrane, e.g., a hot-mopped underlayment, should be installed to provide protection from the water infiltration that may result from the loss of roofing material during high-wind storms (SEE FIGURES 30 AND 31).
3. Manufacturers of roof tile products should provide testing and verification of tile performances under realistic conditions (as addressed by the Code).
 - Manufactures should verify that mortar used with extruded concrete tiles can be installed to Code requirements.

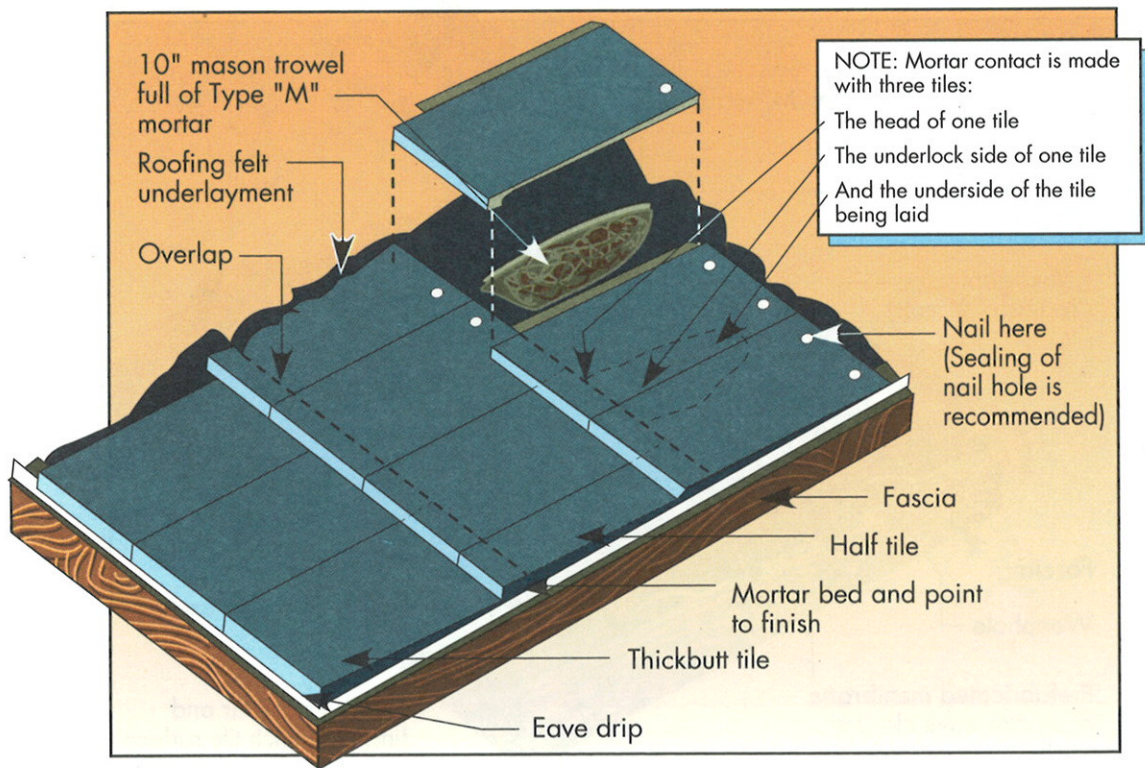
FIGURE 33. *Recommended tile and mortar placement for extruded concrete flat tile roofing system.*

4. Quality control of roof tile installation should be improved by ensuring both consistent mortar pad placements and installation in accordance with manufacturers' requirements, as specified by the Code. (SEE FIGURES 32-37). Though this would improve the survivability of roof tile systems, continued debris impact will result in damage occurring from future wind storms.

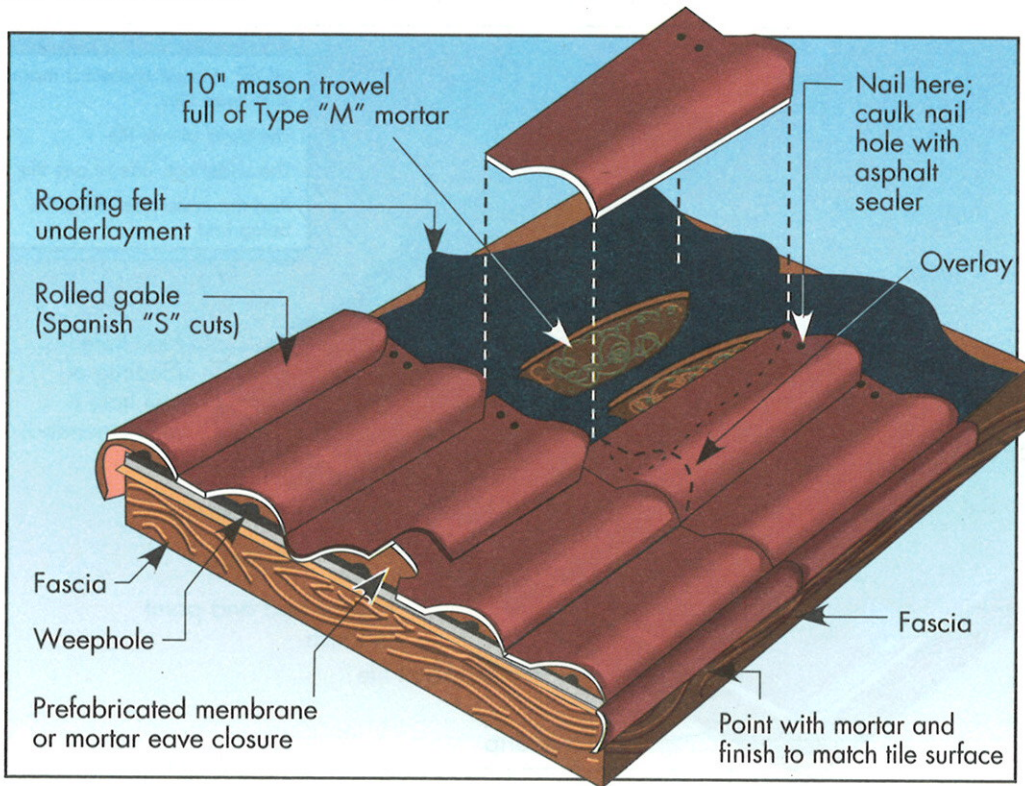
FIGURE 35. Recommended tile and mortar placement for "S" tile roofing system.

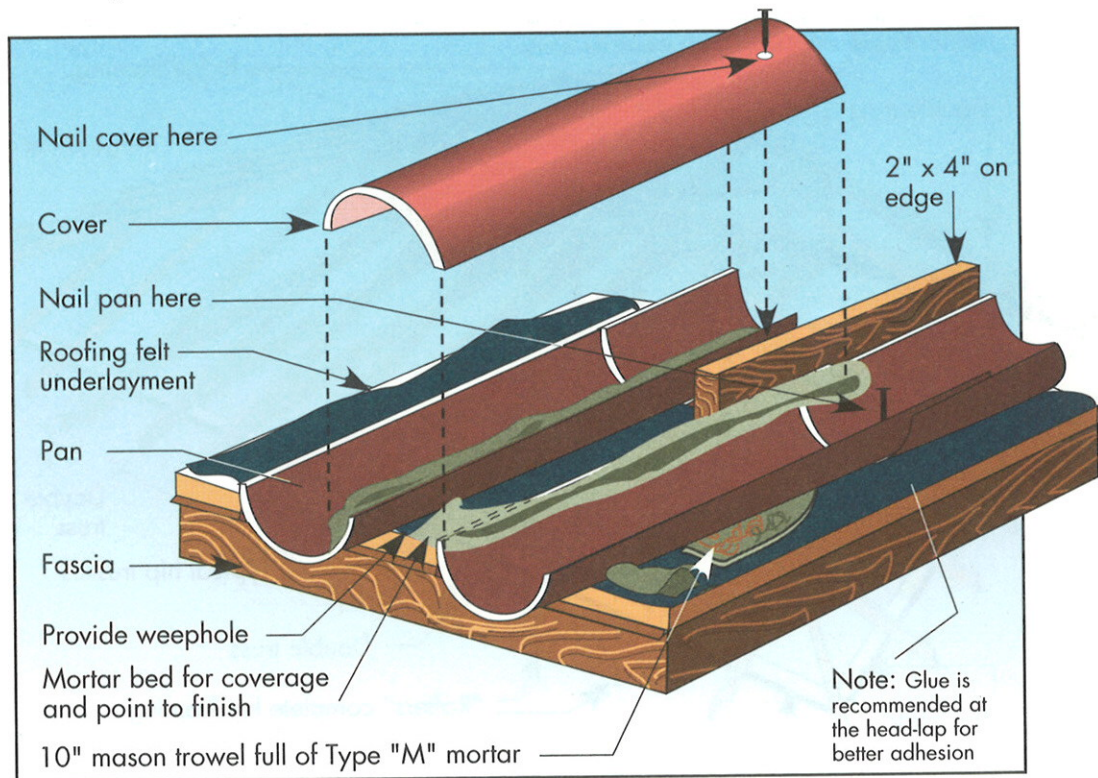
FIGURE 37. *Recommended tile and mortar placement for barrel tile roofing system.*

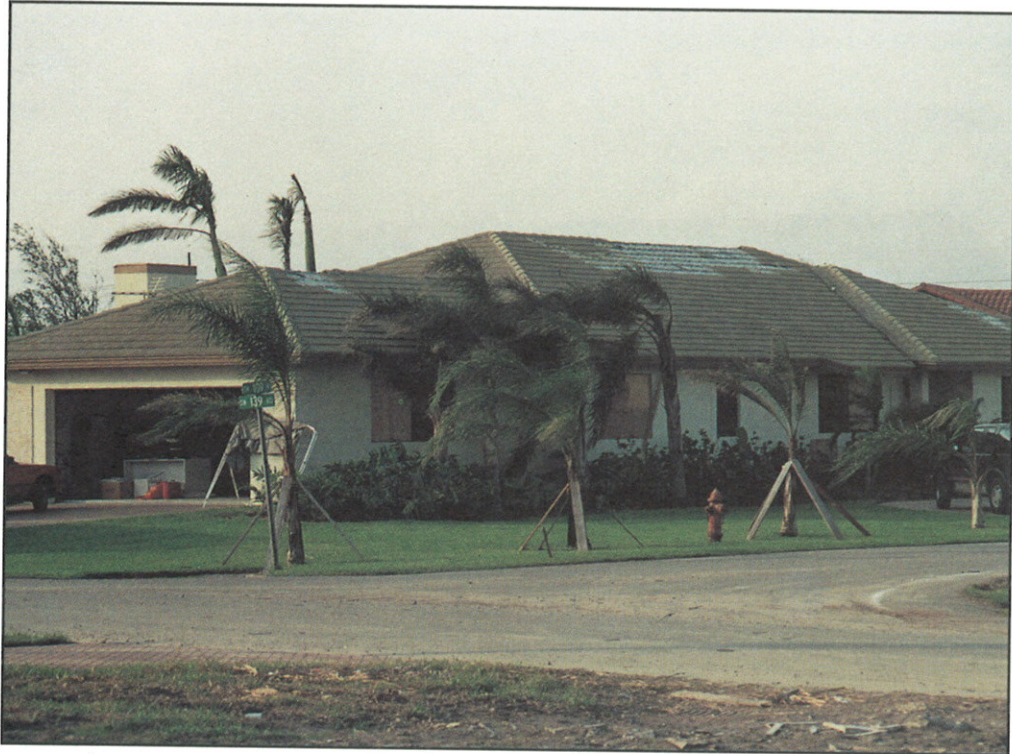
FIGURE 38. *Hip roof.*

5. The design of more aerodynamic building shapes should be encouraged and promoted (SEE FIGURES 38 AND 39). More aerodynamic building systems reduce direct wind forces experienced perpendicular to windward planes of buildings and also the consequent effect of whirling air flows, called vortices, that accumulate at the corners and edges of the planes. The

accumulation of both the direct and negative pressures resulting from these wind flows is particularly prevalent in the more abrupt or orthogonal planes of gabled roof systems.

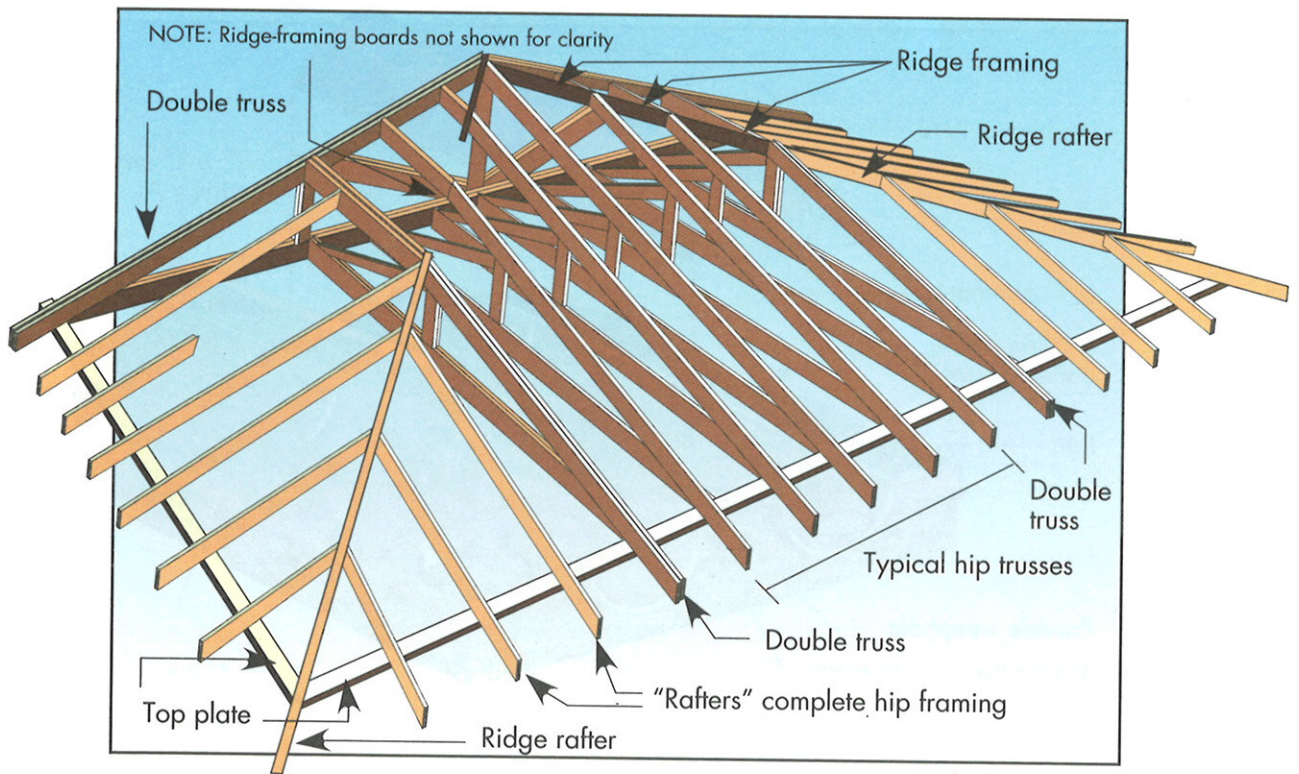
FIGURE 39. *Recommended hip roof framing.*

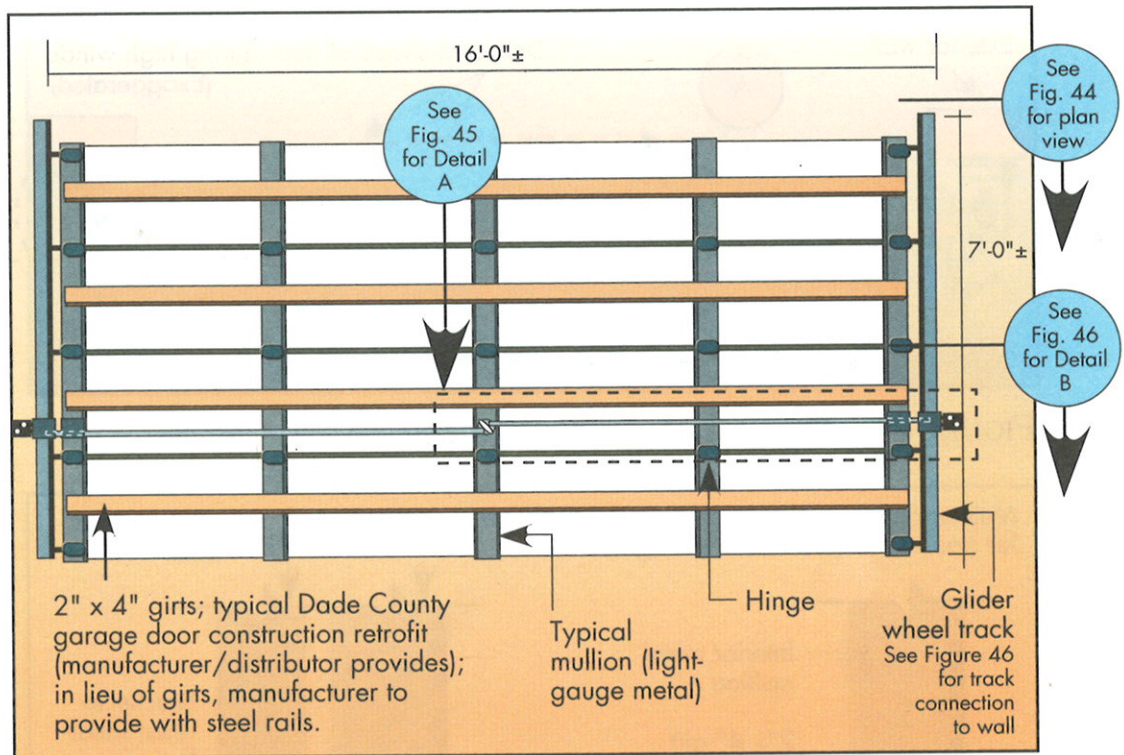
FIGURE 42. Typical garage door elevation.

2. The installation of entire garage door assemblies should be reevaluated for strengthening to resist wind and flood loads.
- In order to reduce the effects of the wide spans of two-car garage doors, the doors should be manufactured to include mullions and girts. Also, manufacturers should reinforce both the security locking system, to provide a wind-force-resisitant latch, and the chain of the door pin to glider track connections, to reduce rotation of the door along its edges. (SEE FIGURES 42-45).

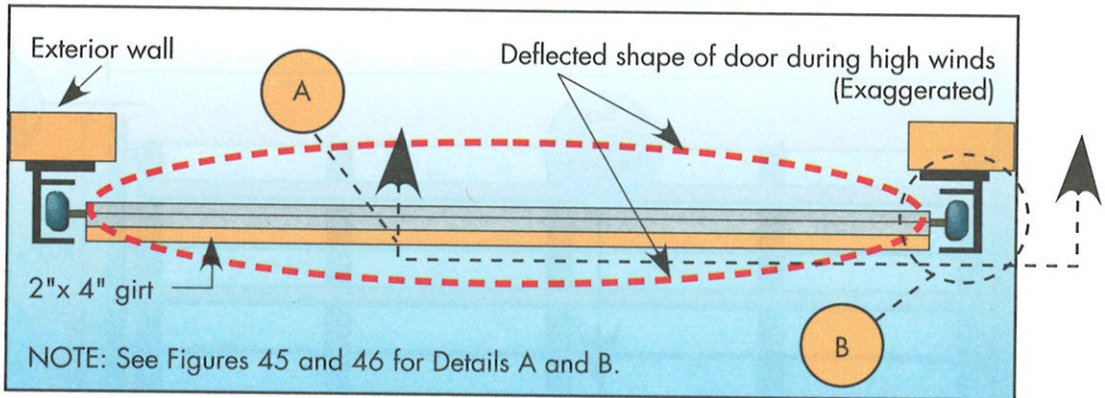
FIGURE 44. Plan view of typical garage door.

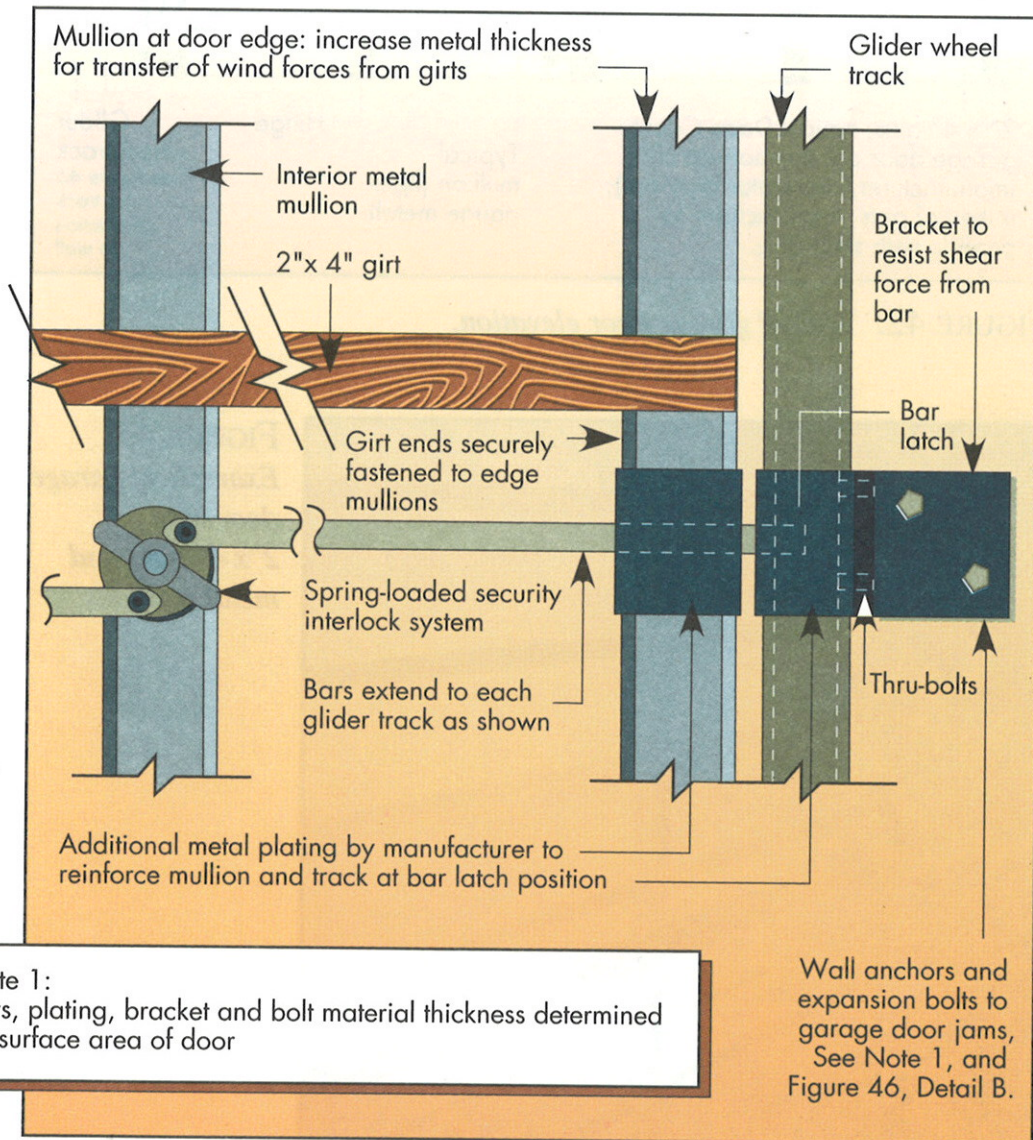
FIGURE 45. Detail A—Recommended reinforced horizontal latch system for garage door.

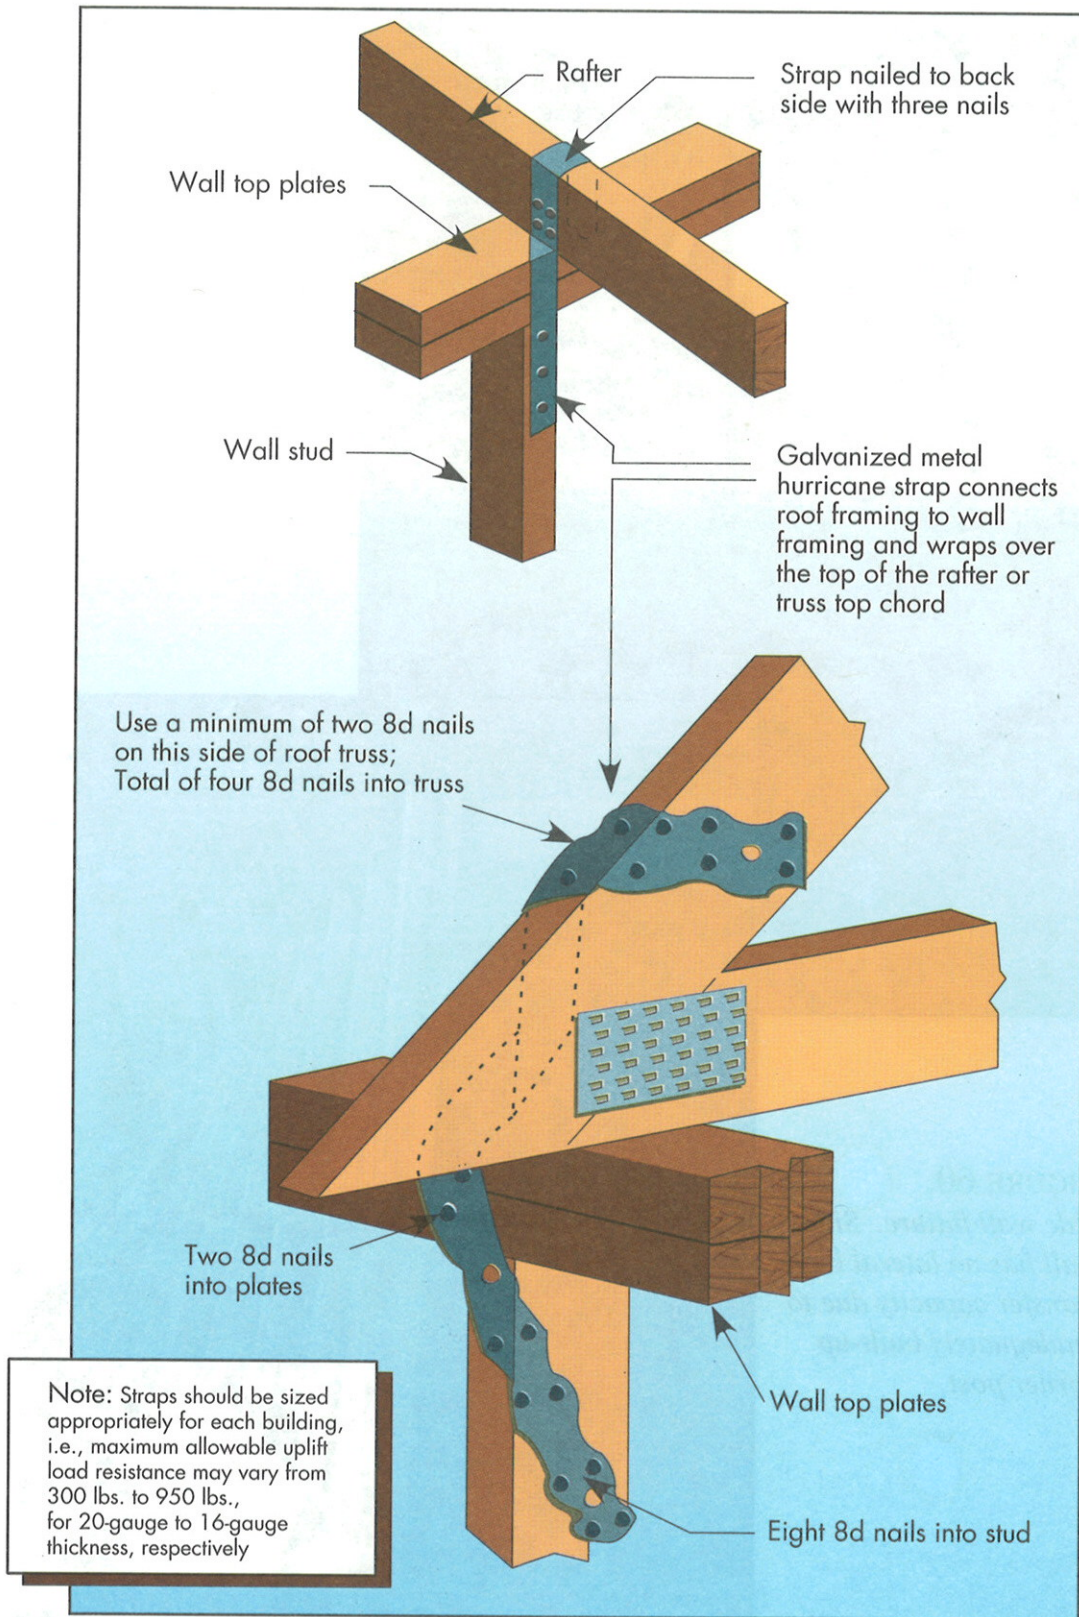
FIGURE 61. Typical hurricane strap to roof framing detail. Rafter or prefabricated roof truss.

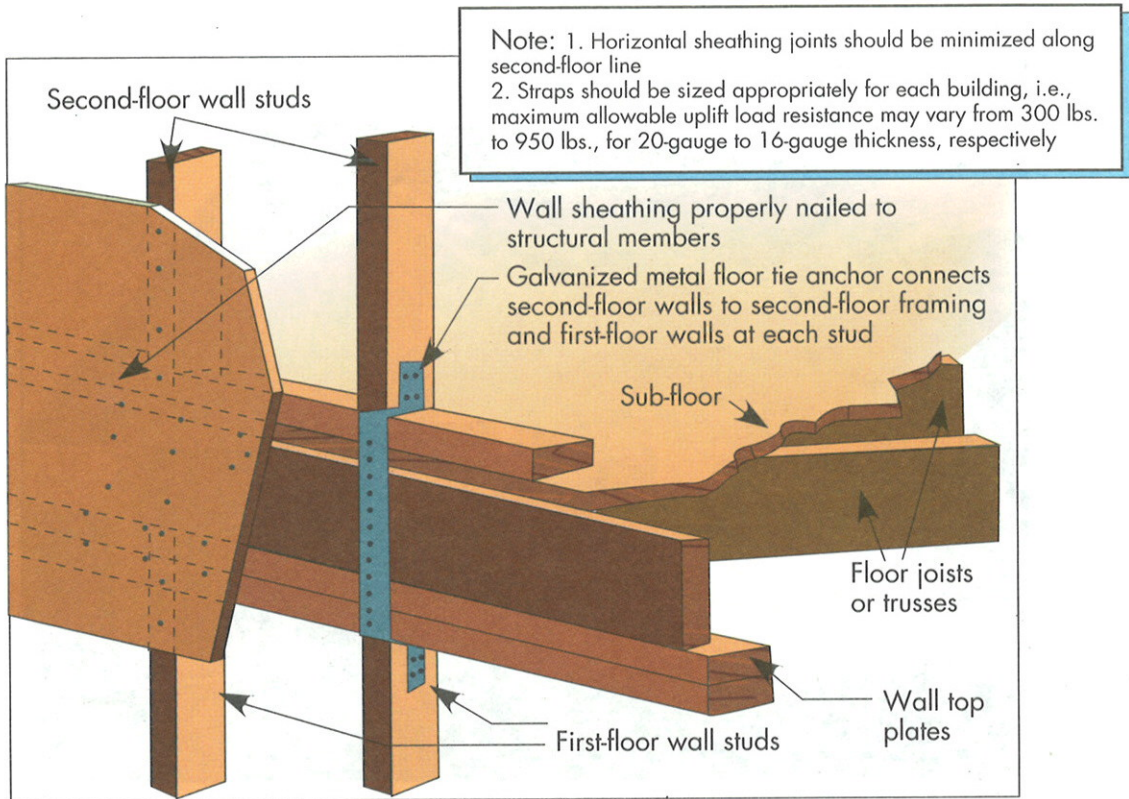
FIGURE 62. *Upper-floor tie to lower floor for two-story building. Floor tie anchor and nailed wall sheathing.*

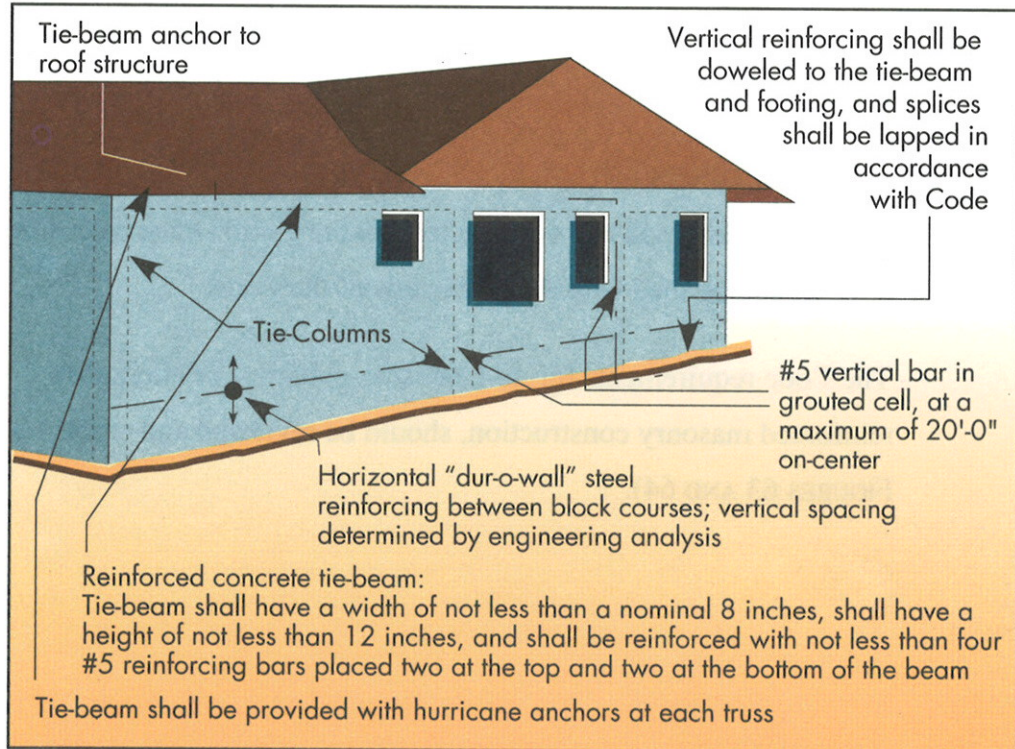
FIGURE 64. *Adequately designed and constructed tie-beam/tie-column masonry wall.*

— The Code requirements for tie-beams/tie-columns, or alternative reinforced masonry construction, should be reviewed and enforced (SEE FIGURES 63 AND 64).

- A tie-beam of reinforced concrete should be placed in all walls of unit masonry, at each floor or roof level, and at such intermediate levels as may be required to limit the vertical heights of the masonry units to 16 feet.

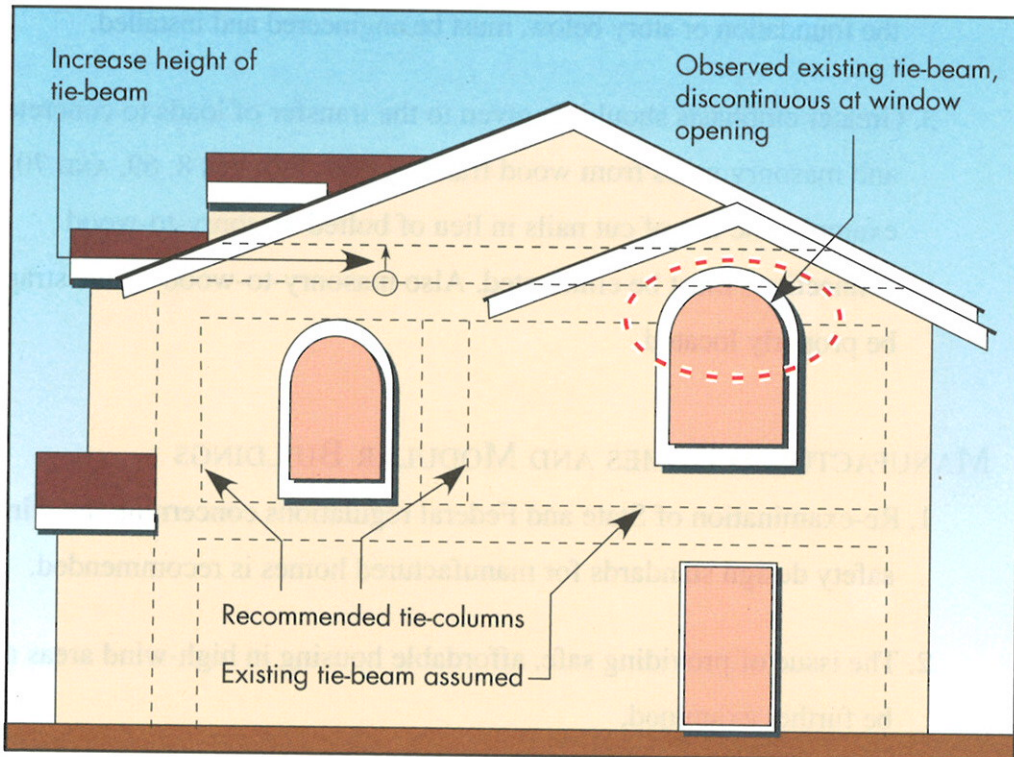
FIGURE 66. *Individualized architectural systems require designs for structural support.*

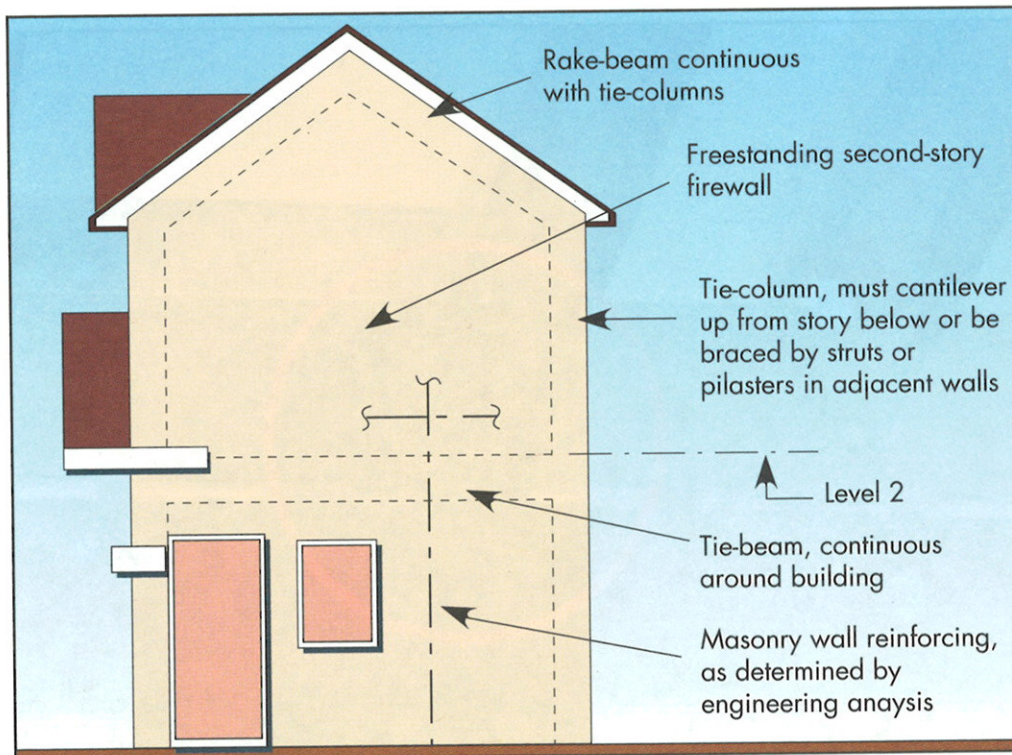
FIGURE 68. Adequately designed and constructed freestanding cantilevered wall system.

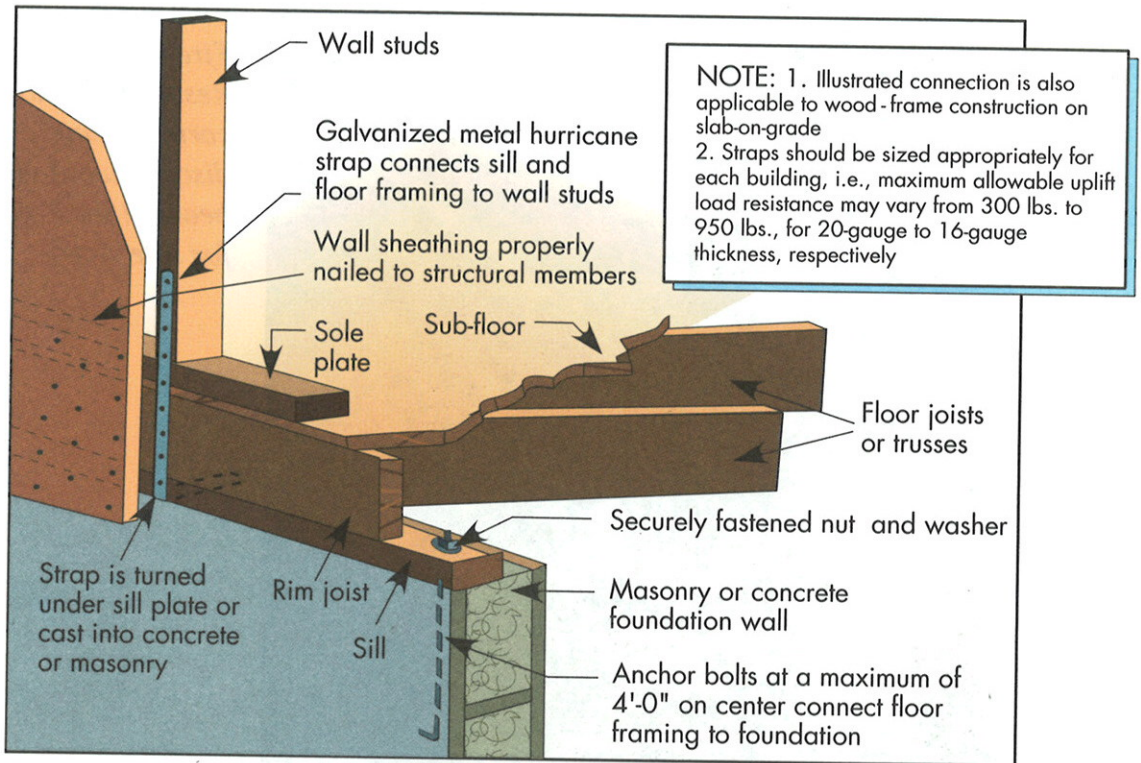
FIGURE 69. Lower-story wall anchorage to masonry (or concrete) base. Straps properly nailed at wall studs.
